LAND ROVER FUEL INJECTION SYSTEM

DESIGN AND FABRICATION

AUTHOR: CIARAN J BRADY
(cb1 at conehead dot org)

Document version - 2.15 - 25th April 2012

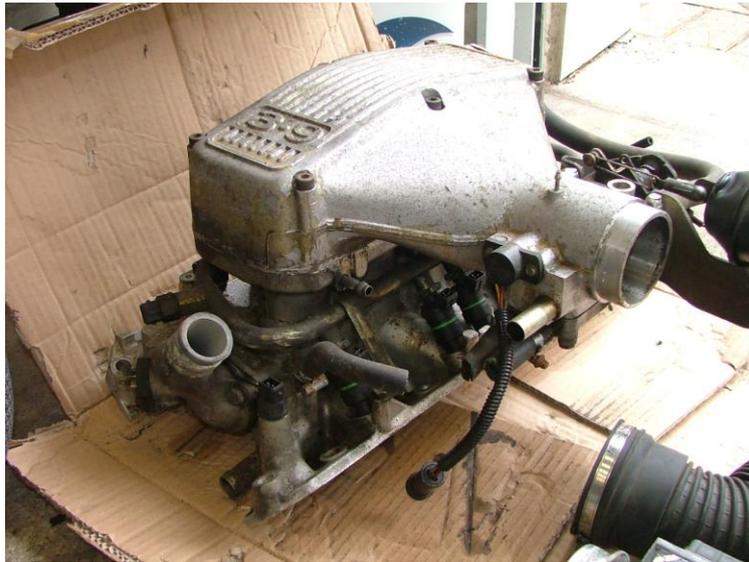
Figure 1 – 1992 3.9EFI donor vehicle parts as shipped

The general condition of the donor parts was good and it was clear that the seller had done a good job of carefully removing the components in order to minimise damage.

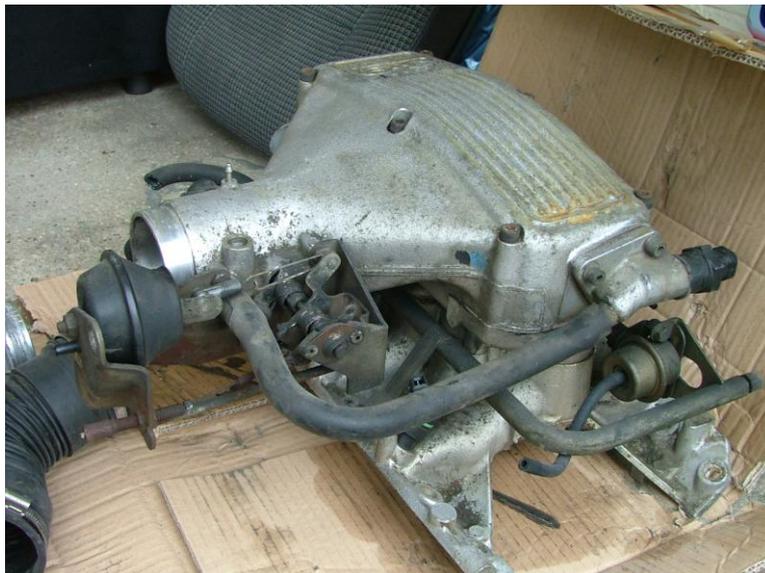
Figure 2 – Plenum side view

The idle control system was intact, as was the throttle linkages and the fuel regulator (at the back of the fuel rail). The throttle linkages did however appear to be in a bad state of repair.

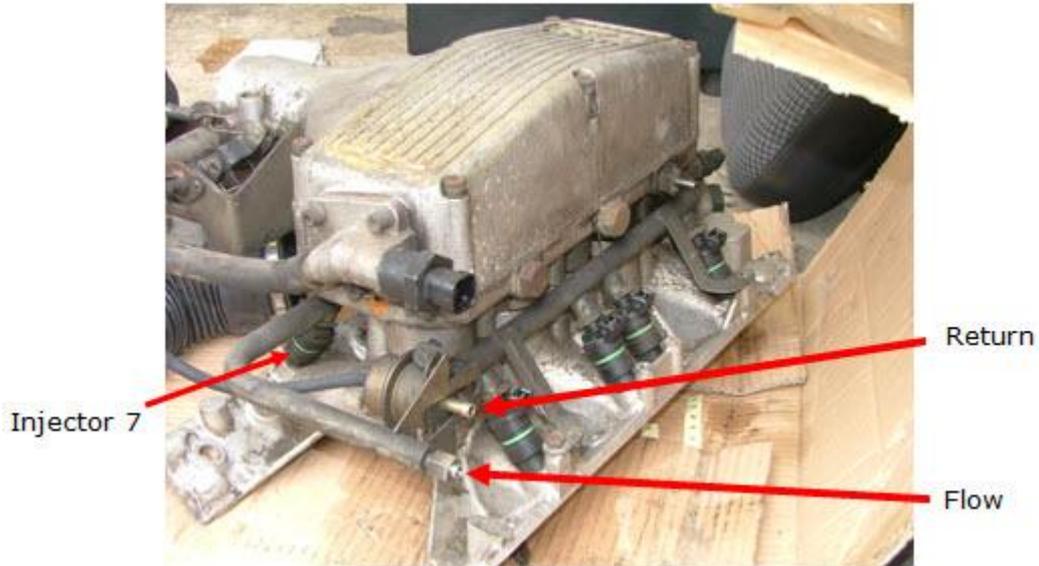
Figure 3 – Plenum rear quarter view – fuel flow and return

In the above photograph, you can see the flow and return feed pipes to the fuel rail, connected to the even bank of injectors (with the injector for cylinder 7 visible at the back left). Note the fuel rail connections – using a standard hose jubilee pipe on the low pressure side of the fuel regulator, but a machined fitment on the input high pressure side. This machined connection was tackled by removing the olive and the free rotating nut and using a standard jubilee clip connection on the rail after soldering a lip onto the pipe.

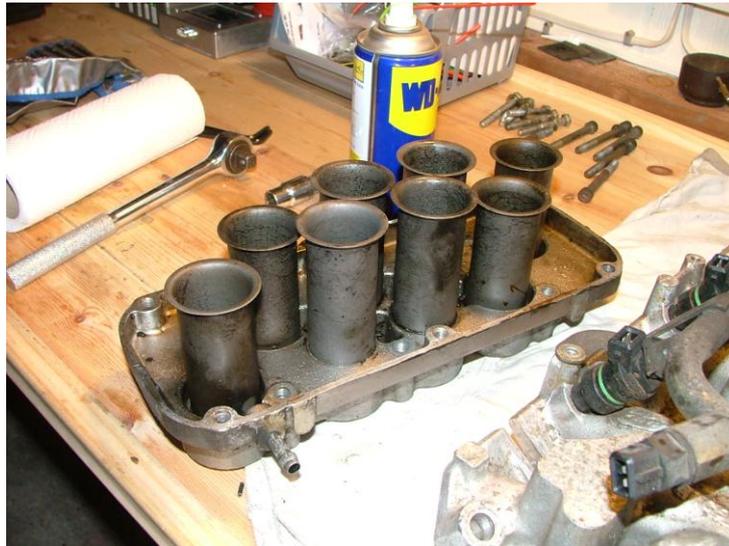
Figure 5 – View of Intake runners

The above photo shows the intake runners which bolt to the intake manifold via 6 bolts, and which the upper plenum (shown below) screws to via 6 hex head screws. An important point to note here is that the intake runner platform is actually reversible – and can be mounted either way on the intake manifold – a design advantage that was used to simplify the vacuum pipe routing.

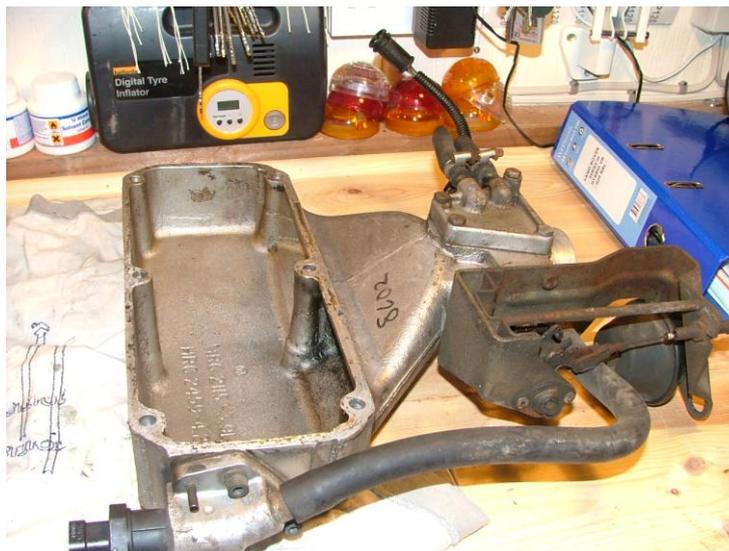
Figure 6 – Underside of plenum.

as well as the throttle linkages. Note also the cable and plug for the throttle potentiometer sensor.

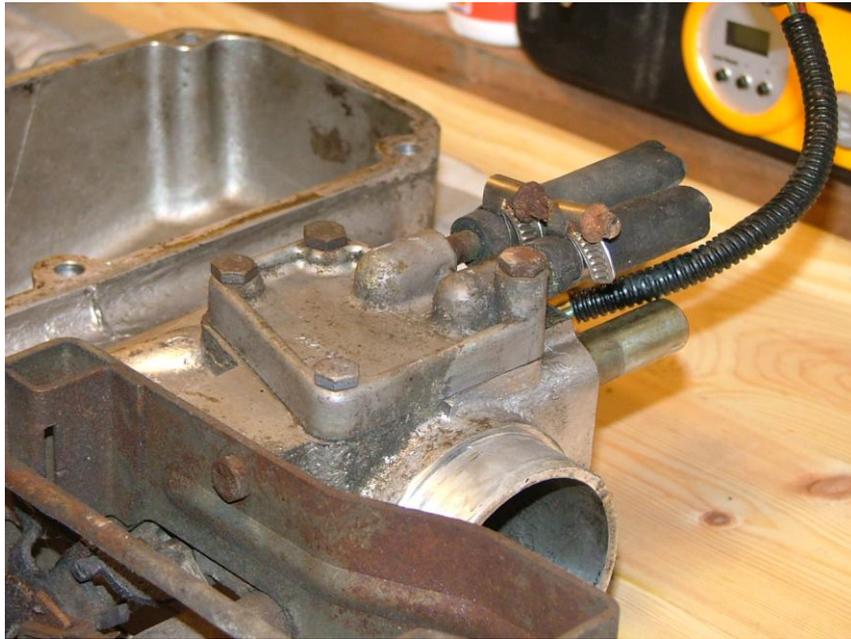
Figure 7 – Close up of plenum chamber pre-heater

The above figure shows the plenum upside down. The primary metered air entry point is the large round point, and the pre-heater plate is shown above with the two heater hoses.

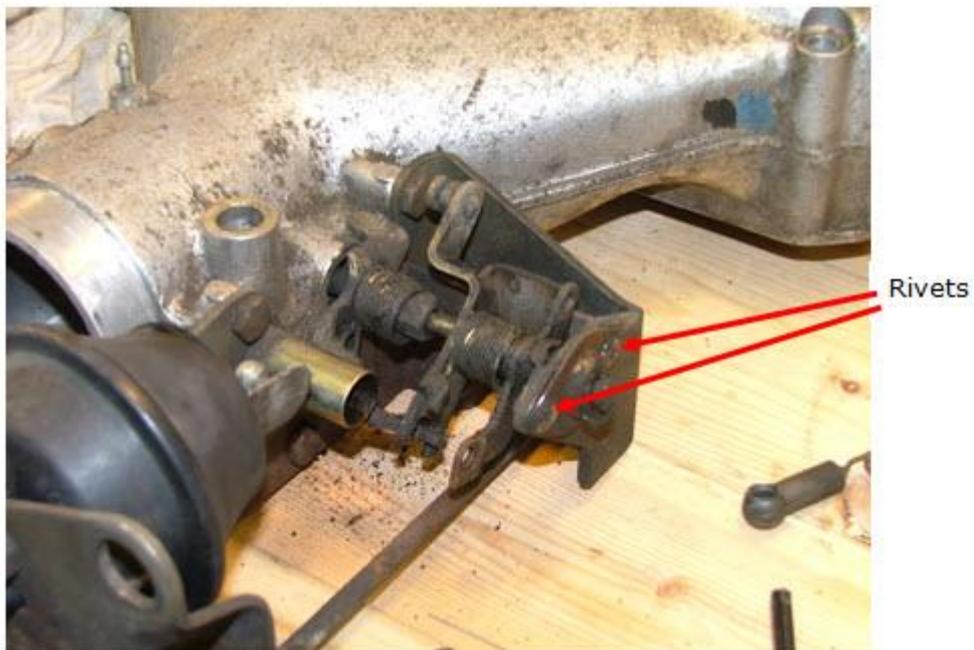
Figure 8 – Close up showing the throttle linkage

The throttle linkage looked in a very bad state during the initial inspection – however after cleaning and refurbishment it quickly became clear that the linkage was in exceptionally good condition with very little wear. Stripping the linkage involved drilling the rivets (shown on the RHS bearing) and replacing.

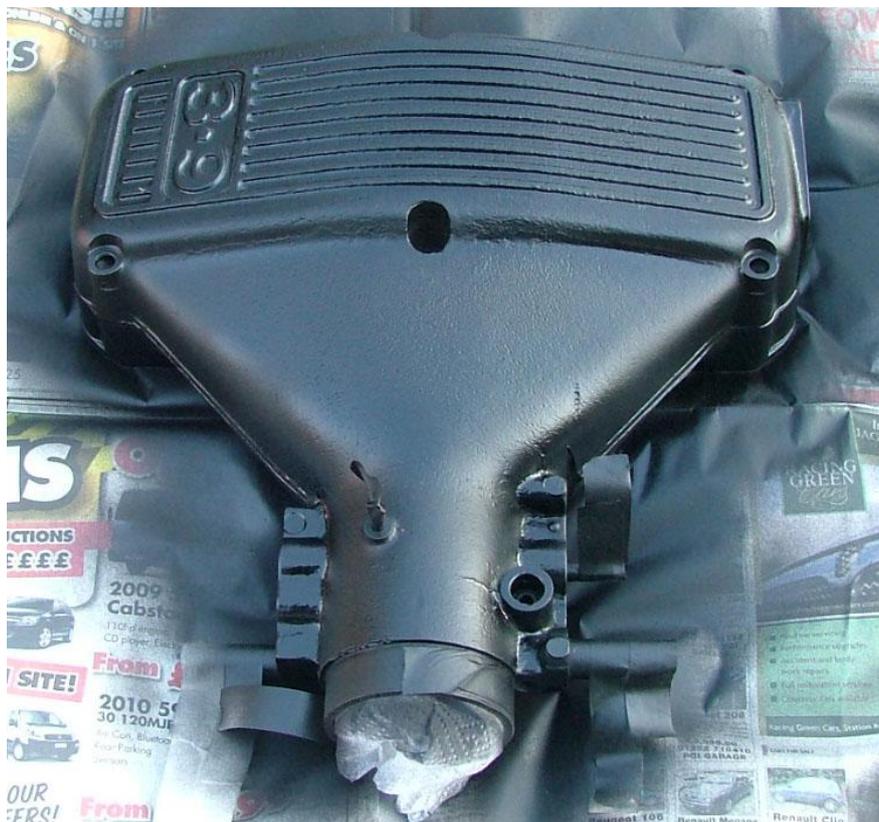
With the degreasing and refurbishment complete, a new coat of paint was required. Matt black was used for everything other than the fuel rail (which was sprayed a bright red colour from Rover).

Figure 10 – Painted plenum - minus all ancillary components

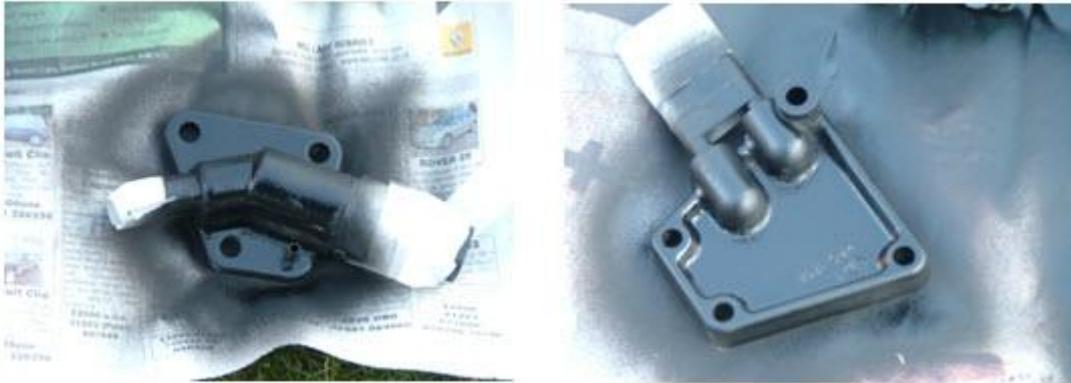
Figure 11 – Sprayed idle bypass air valve housing and plenum pre-heater

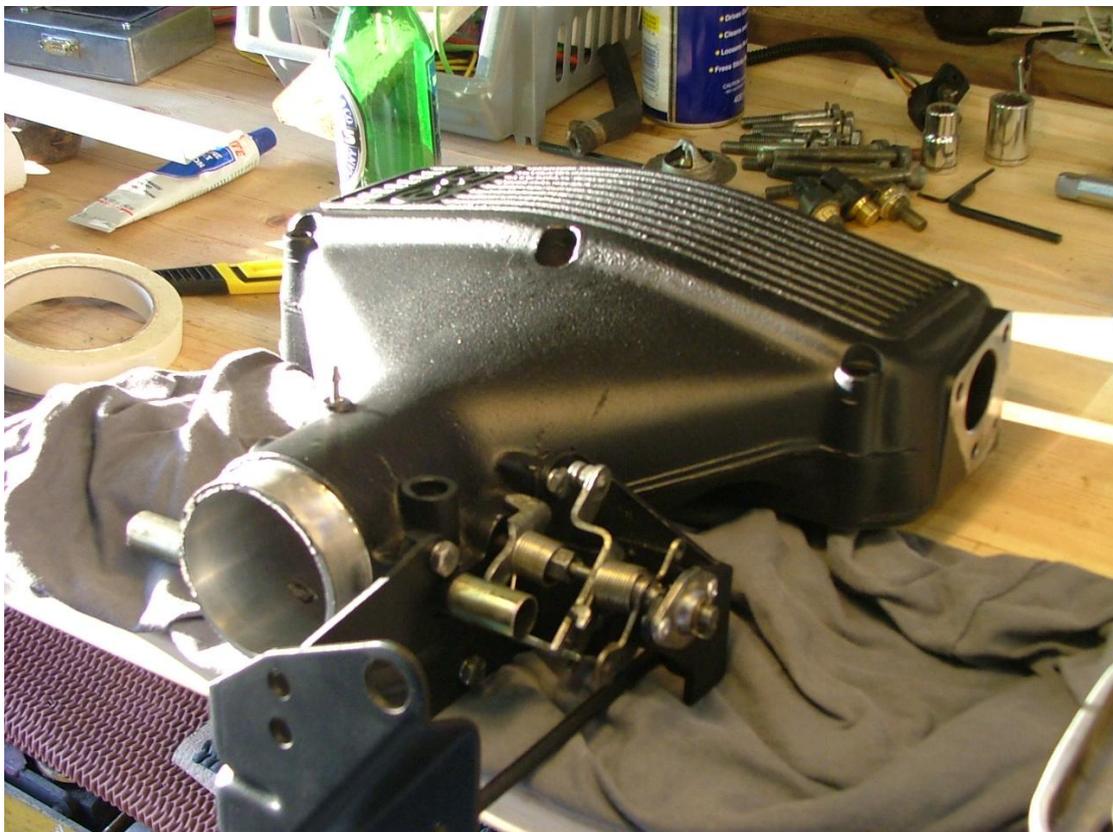
Figure 12 – Sprayed plenum complete with rebuilt throttle linkages

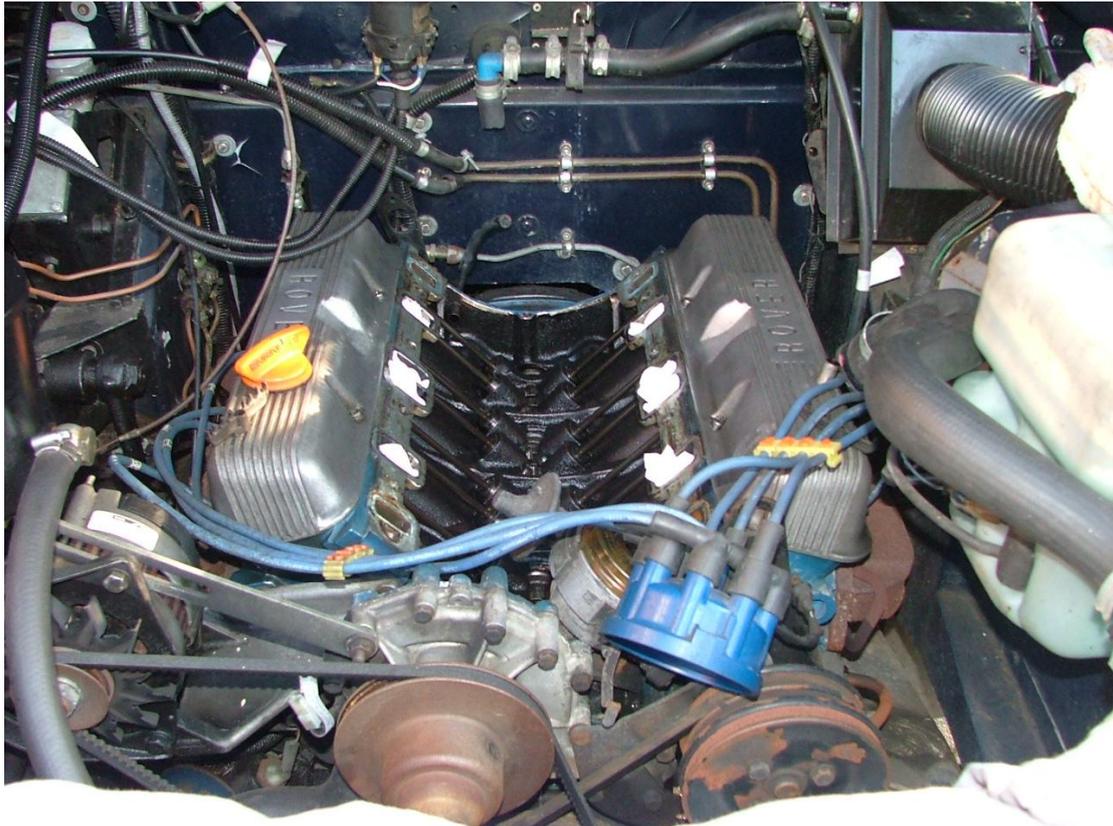
Figure 13 – Rover V8 cleared down to the valley

Meanwhile – all the work required to clear the old carburetion system on the land rover had commenced to the point of leaving the valley clear

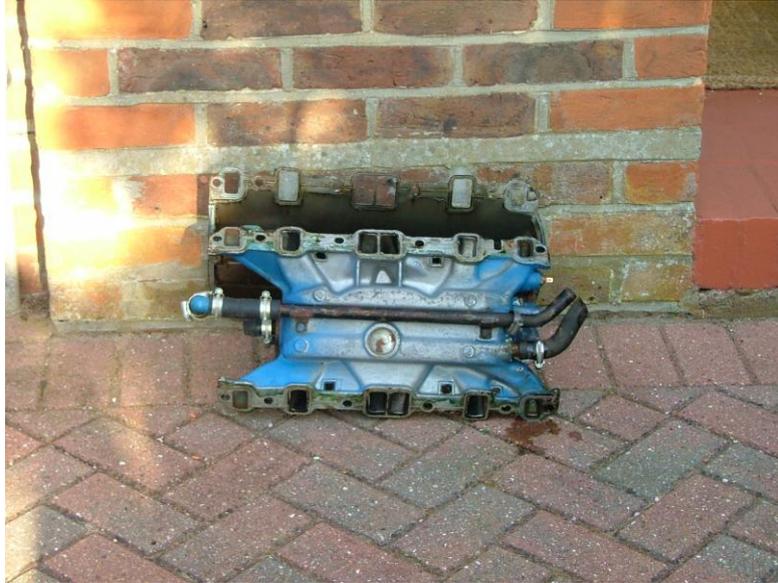
Figure 15 – Underside of original carburettor manifold (showing the plumbing)

With the original intake manifold the top and bottom radiator hoses followed a conventional route – although the top hose was interrupted (close to the radiator) by a metal unit holding two temperature switches designed to operate the two electric radiator fans. Closer to the manifold, the water pump had two ports which connected to hoses – one which was about 4" long and which connected to a corresponding metal pipe in the intake manifold front body (shown above as the bottom right hand most pipe). The second connected to a full length metal pipe screwed to the underside of the manifold. At the back of the manifold the screwed pipe and a second metal pipe in the intake manifold rear body acted as the flow and return feeds for the heater matrix.

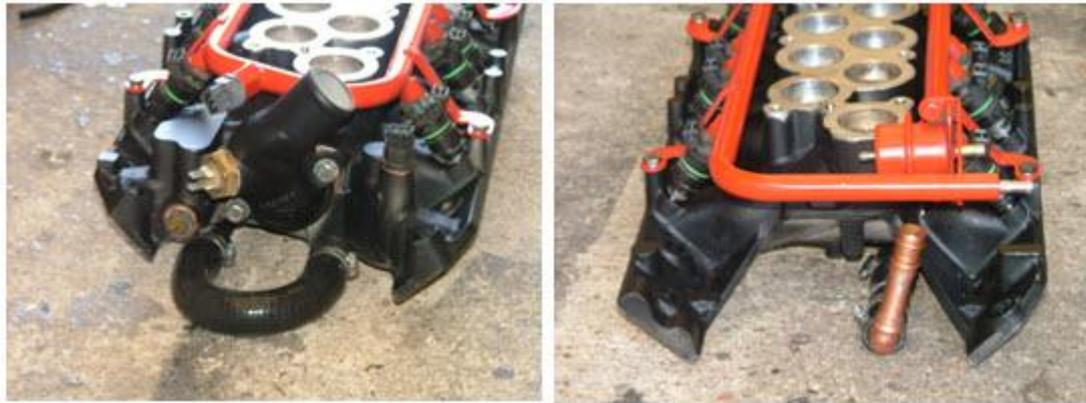
Figure 18 – Intake front and rear view

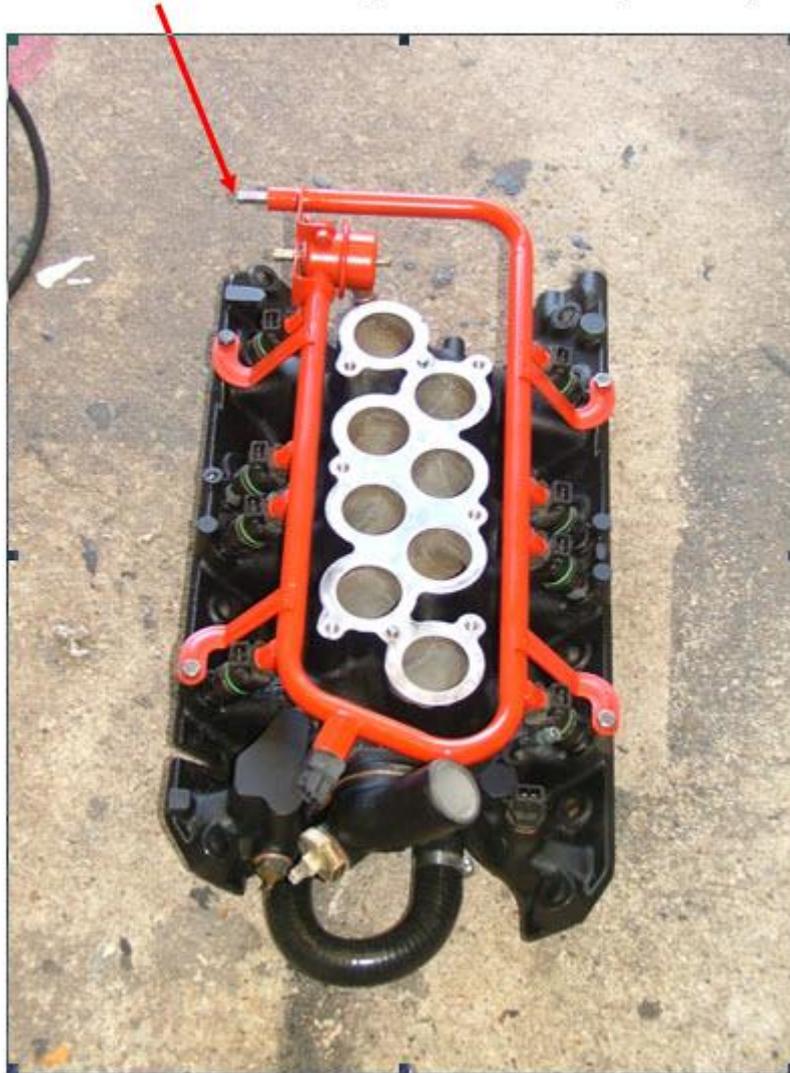
New fuel flow connection – redesigned for hose and jubilee clip

Figure 20 – Finalised injection intake base

The figure above shows the fully built injection manifold complete with refurbished injectors and fuel rail – note the converted fuel pipe connection on the rear of the fuel rail - now converted to use a standard hose connection

As part of the refurbishment, all eight injectors were sent to a specialist cleaning company (who also supplied the oxygen lambda sensors). Their injector cleaning service included replacing the pintle heads, all O rings (2 per injector) followed by ultrasonic cleaning and then a testing phase to assess the coil electrically, and to check the flow rating for each injector at 3 bar pressure along with measured leak down loss and spray pattern.

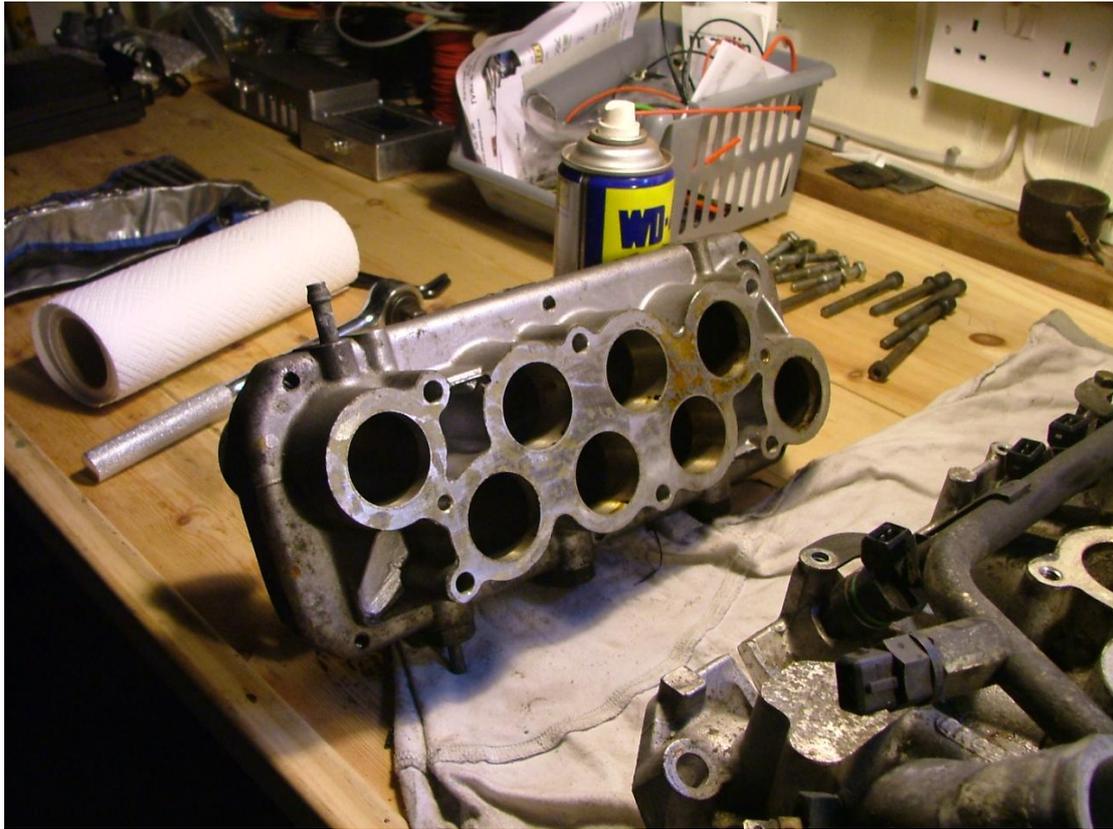
Figure 21 – Underside of plenum intake trumpet housing (note vacuum ports)

The selection of orientation for the trumpets was easy – given it is a reversible section of the intake. The external vacuum ports on the trumpet housing were the deciding factor given the need for the brake servo on one side, and on the other a PCV feed at idle, and the vac gauge. *(Note that the distributor advance/retard is fed from the port on the upper surface of the plenum, and the fuel regulator is fed by the port under the idle bypass air valve stepper motor).*

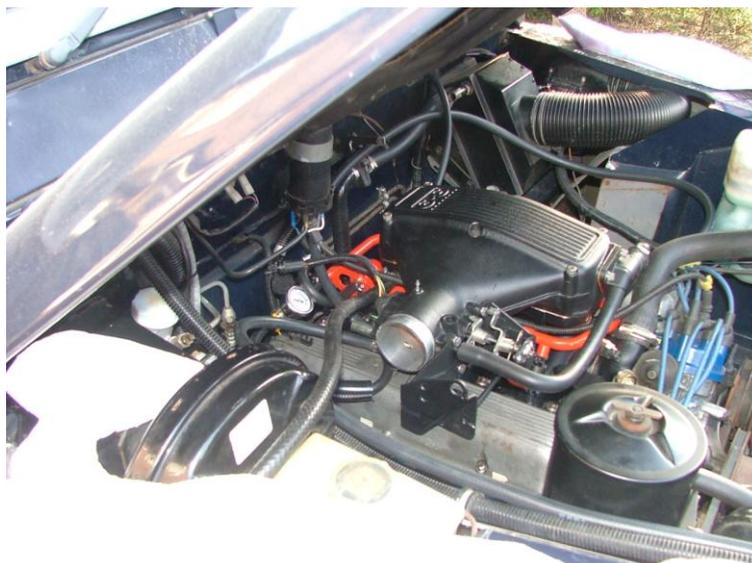
Figure 22 – Final position of the plenum

The one downside with this arrangement was that the route from the air intake to the logical place for fitting the mass air flow sensor required a tight C shape.

The arrangement of placing the plenum chamber with its air intake towards the drivers side meant that it was possible to reuse the existing throttle cable.

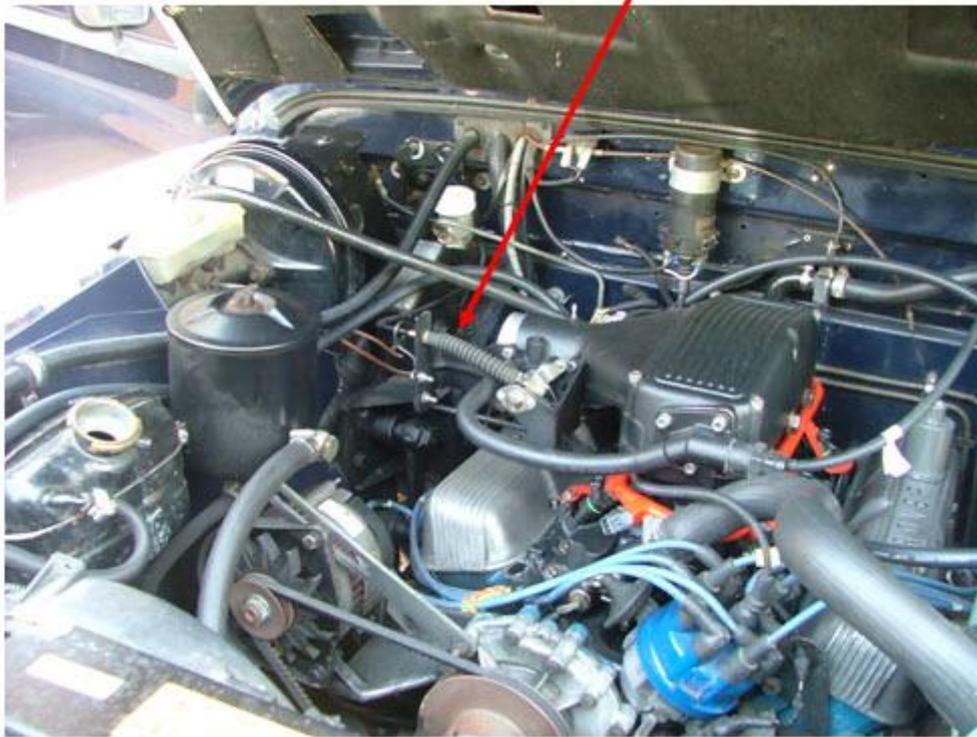
Figure 23 – Throttle fabrication

However, the existing throttle assembly steel frame fouled the intake metal air pipe running from the plenum to the mass air flow sensor assembly and so had to be discarded. The throttle assembly was cut back, and welded strengtheners were added to the existing frame. A bracket was then constructed (see below) and welded to the assembly to accommodate the throttle cable (the mounting bolts were then removed and the holes filed with weld).

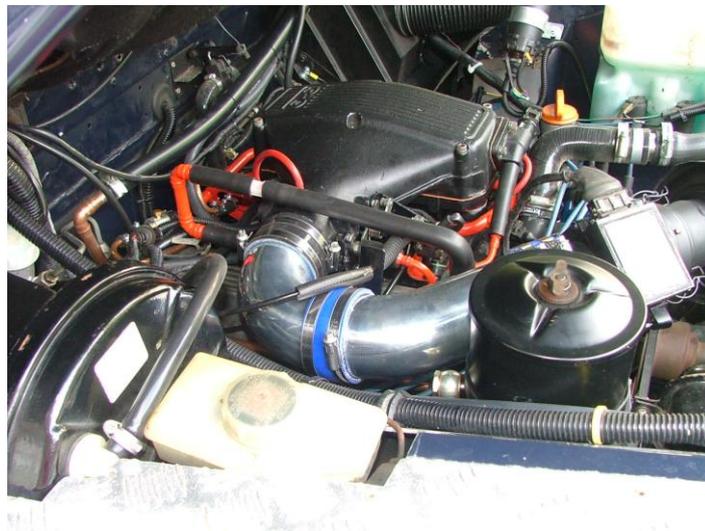
Figure 26 – MAFS air path

The solution (which passed through three different unsatisfactory designs) consisted of the following. First, a 20mm deep stainless steel sleeve was

One complication to this solution was that the 90 degree radius pipe when fitted fouled the throttle assembly frame. In order to resolve this, the entire throttle had to be disassembled, cut and welded to permit adequate clearance while ensuring it was strong enough not to flex.

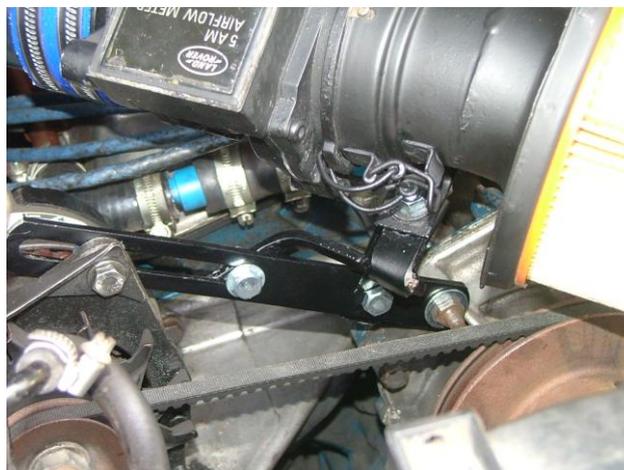
Figure 27 – MAFS mounting bracket

There are four bolt holes in the MAFS mounting bracket. Two bolts mount the bracket firmly on to the adjustment swing arm used to hold the alternator. An

With the main air intake pipe routing fitted and with clearance ensured all round the intake pipe (especially near the power steering reservoir canister – allowing for engine torque motion) the mount for the MAFS box and air filter was then created.

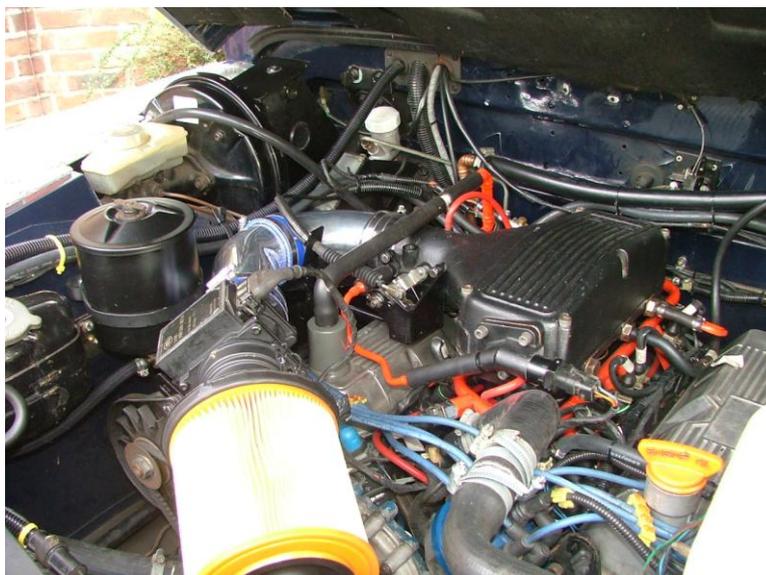
Figure 28 – Mounted air filter (outer canister removed) clipped to MAFS

The donor vehicle air filter unit was the standard Land Rover EFi metal canister unit using a solid clip coupling to the MAFS, a main body and a lid with extended nozzle for the raw air intake. There was interestingly no air preheating feature on this unit. The outer canister steel was also badly rusted on the donor part even though the base was in good condition. An elegant temporary solution involved grinding off the outer canister welds leaving a base with proper clip couplings to the MAFS and an elongated bolt fixing mechanism for the air filter (a standard range rover filter).

While this air cleaner solution worked well in dry conditions it was less than ideal when driving in rain because any rain water passing through the radiator would hit and therefore dampen the paper air filter. This caused the element to loose its shape and its ability to properly seal. A second hand standard land rover air cleaner in fairly good condition was therefore purchased, cleaned and modified to shorten the snorkel so that it didn't foul the radiator fans. The finished result was then primed and sprayed matt black. See the two figures below for both views of the modified air cleaner.

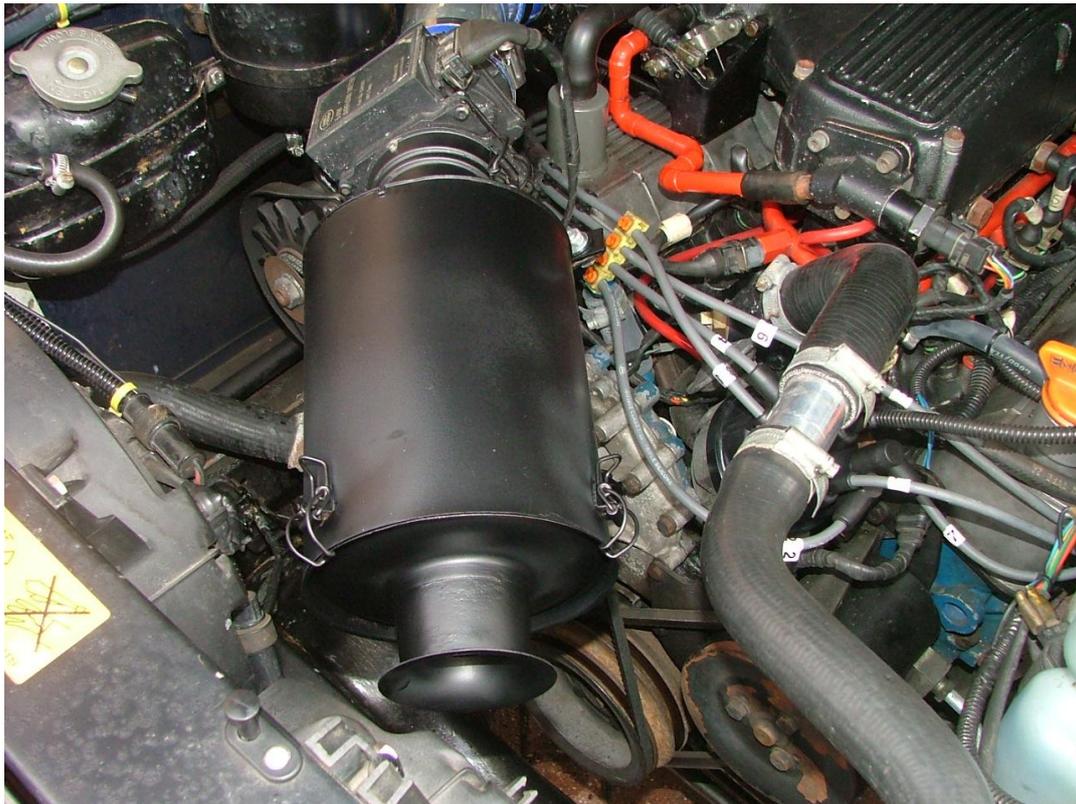
Figure 29 – Modified air cleaner box used to weather proof the intake air filter

Note in the above figure the shortened snorkel (which is much longer on a normal Land Rover air cleaner).

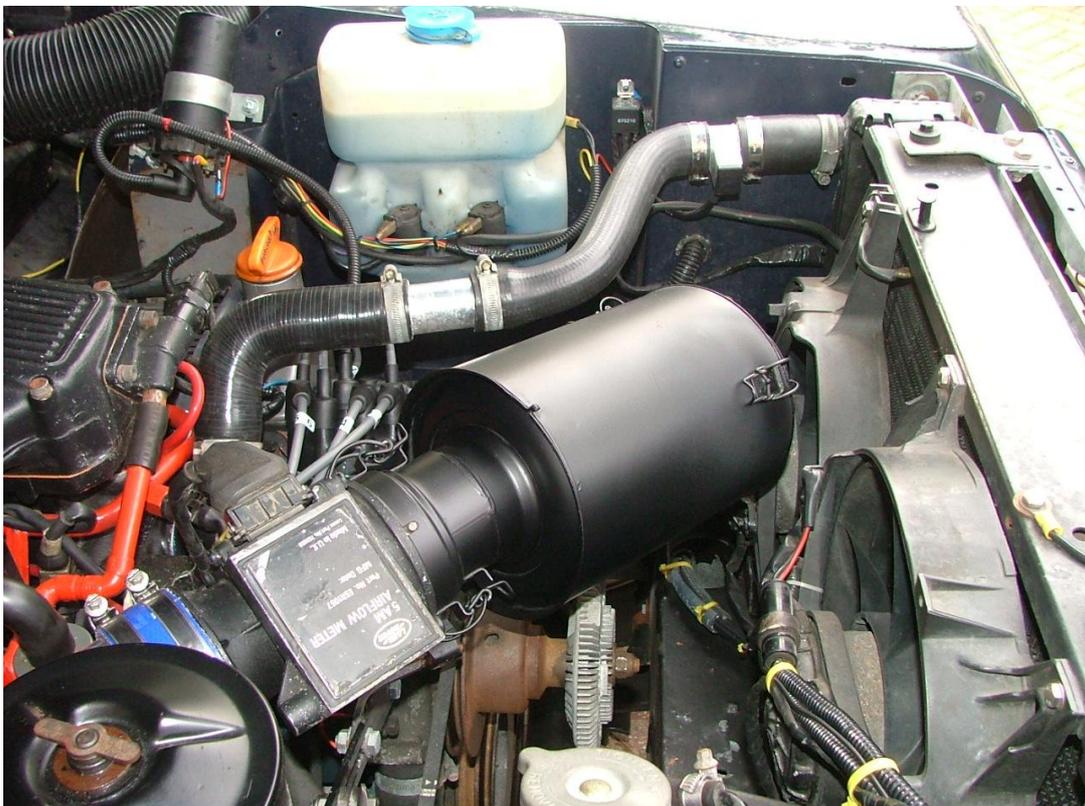
Figure 30 – Modified air cleaner box rear view (note MAF sensor clips)

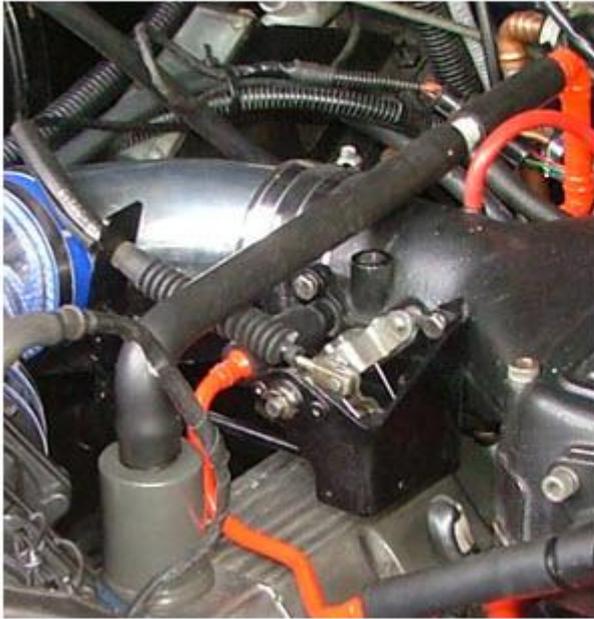
The image below shows the PCV hose run from the oil separator to one side of the plastic T piece.

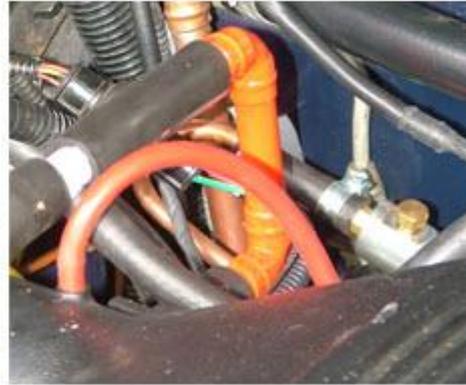
The close up below shows the routing from the rear of the T piece to the plenum port (via a 15mm copper U bend painted red). The third vacuum pipe leaving the plastic T piece is just visible heading down under the plenum chamber.

Figure 33 – View of the PCV system pipe routing

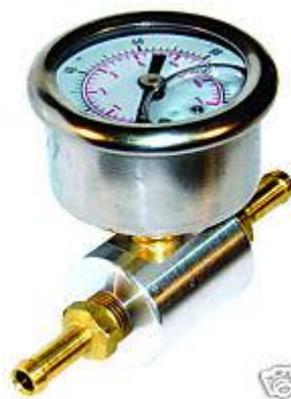
Figure 36 – Fuel pressure tap off point

The fuel line ran up the firewall to the rear of the engine – and then connected to an aluminium block threaded with three holes – two designed to accept 8mm hose ends, and a third tapped to suit a 1/8th NPT non-permanent fuel gauge. After testing this gel filled gauge was removed and replaced with a threaded block plug.

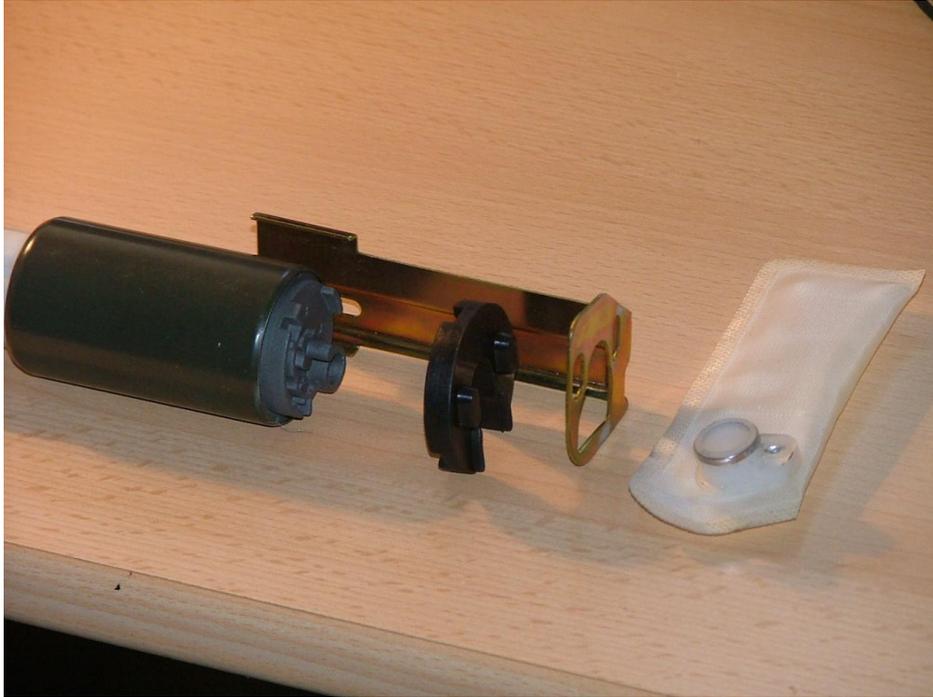
Figure 38 – Wet pump deconstructed

On the left side, the pump assembly consists of a white plastic porous filter allowing fuel to pass into a small but powerful, 3 bar pump via an 8mm opening. The pump output is coupled by a short hose to the 8mm pipe extending out through the cover mount flange plate complete with protective green cap. The lower end of the pump is supported by an L shaped steel bracket secured with two nuts (each having a small degree of adjustment) mid way up on its long side. The bracket is not secured to the bottom of the pump. Instead it fits over small extrusions on a rubber collar (see the black part below, sandwiched between the pump and the metal bracket). The fit is loose, but in such a way that the pump is cushioned (which helps reduce noise), supported vertically, and can't rotate

The pump support bracket is electrically earthed, and surrounds the fuel intake filter – providing an effective earth screen for incoming fuel, while also serving to physically restrain the pump. Hazardous fuels are often electrically screened to eliminate the build-up of static electricity as fuel flows into a rotary pump. This may seem like an esoteric safety feature, but over large production runs, especially when fuel tank levels become relatively low (giving rise to large volumes of air in the tank), there is a strong incentive to minimise any build up of static electricity.

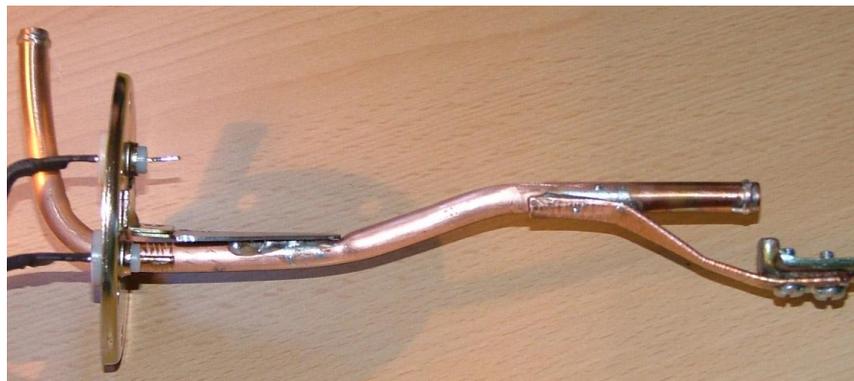
As stated above, the copper pipe at the bottom of the back plate was bent with a “gentle kick bend” to ensure that the pump assembly would clear the float arm when at the tank empty position. The bend extends for roughly 2 inches at which point the pipe was again bent the opposite way to straighten - so that it dropped straight down into the tank.

Figure 43 – Pipe bend layout (ignore the brace shown on the bottom right)

The distance from the bottom of a SWB series 3 fuel tank to the top surface of the mounting flange on the outside of the tank is exactly 12.75 inches (323.85mm). The length of the copper feed pipe must be left as long as possible to ensure that the pump intake filter is as close to the bottom of the tank as possible (ie: brushing the bottom) whilst allowing sufficient room for a pair of jubilee clips and a short length of high pressure DIN rated fuel hose to adequately couple the pump to the copper pipe. For this implementation, the coupling hose was 2.75 inches long. The lower end of the copper pipe was then cut to length and two lips were soldered onto both pipe ends (making it suitable for hose connections) using wrapped solid core wire, soldered and then filed and brushed

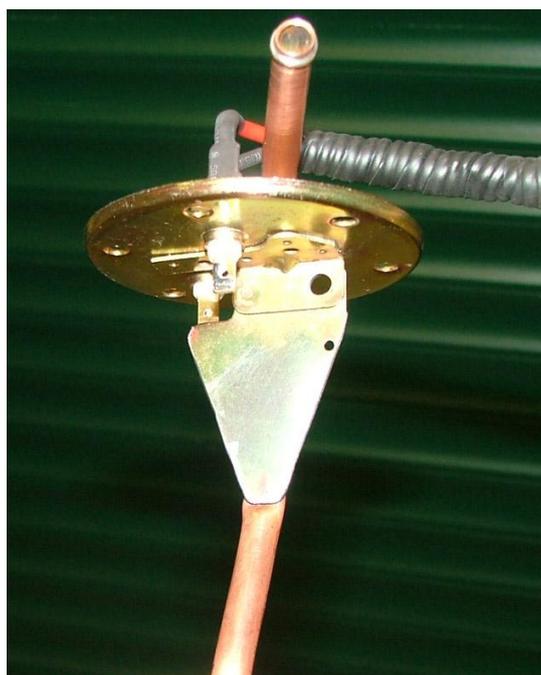
Figure 45 – Module side of the new assembly

Araldite 2022 has a different composition than standard Araldite available at DIY stores. It is characterised as having particularly strong resistance to petrol and was therefore the selected epoxy of choice. The reverse side of the new assembly shows the bare mounting position for the replacement electrical module – as shown below.

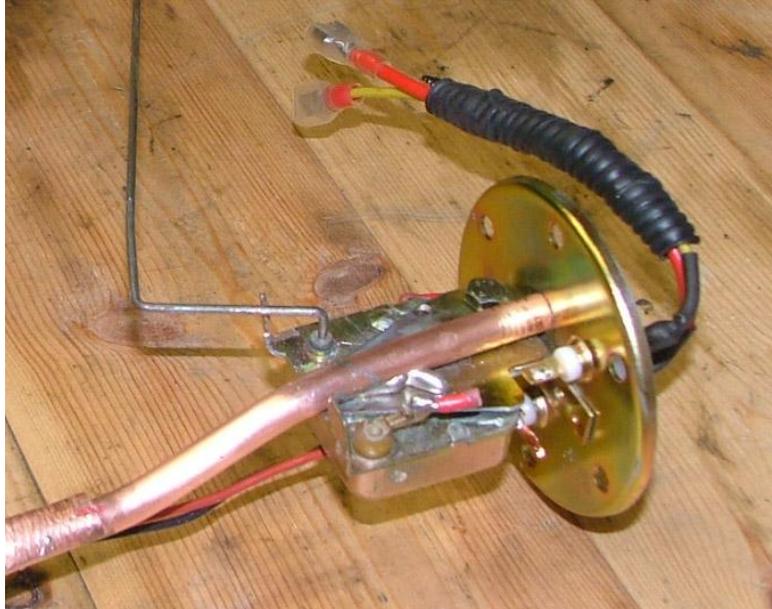
The electrical module taken from assembly A was then fixed to the back plate. A thin layer of mixed Araldite 2022 was applied to both surfaces and the two metals

were brought together. Then an M4 bolt was fitted with locking and scratch washers to ensure electrical continuity. The M4 bolt was new (ie: not pre-stretched) and was tightened firmly. Epoxy was then used to seal both sides of the copper pipe as it passed through the main mounting flange. 24 hours were allowed to pass before the assembly was moved.

Figure 46 – Electrical module fixed onto the back plate

On the top outermost side of the unit there was one risk that some unsuspecting engineer could connect the pump feed to the gauge wire given two identical male spade terminals were exposed. This could be rather dangerous, because the design would permit the mechanic to connect the pumps high current +12v feed to a wire wrapped potentiometer, which would in all probability glow cherry red inside the fuel tank as soon as the ECU powered the unit up. As such, the spade terminals on the top of the mounting plate have been soldered, and hard wired to male and female spade connectors on colour coded wires. The metal terminals in the mounting flange were then surrounded with heat shrink to prevent any direct connection. The sex of the connections ensures that the wiring cannot be accidentally reversed.

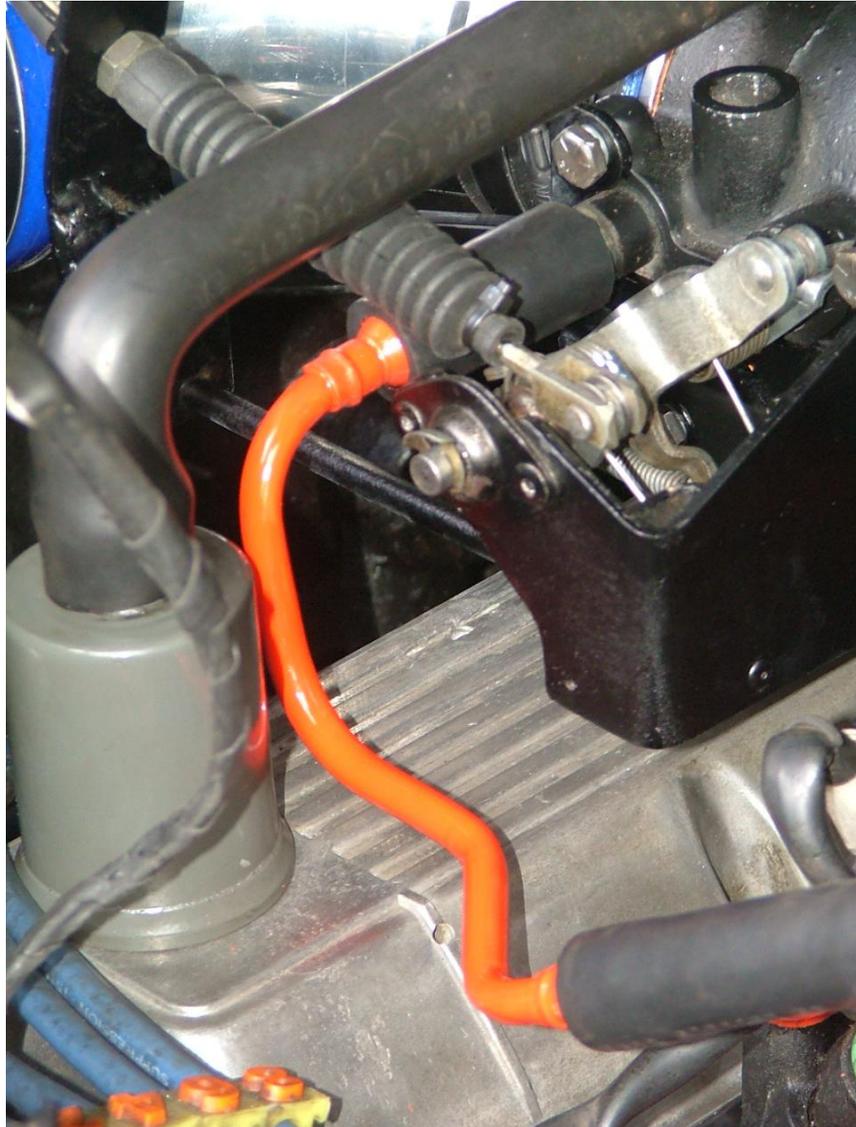
The third problem (as stated above) was that the standard Land Rover hose linking (B) to (C) fouled the new position of the PCV oil separator. The hose was therefore discarded, and replaced with two short rubber hose joiners, and a neatly bent 10mm copper pipe with soldered 10mm to 15mm reducers on both ends (all painted red). These reducers were a snug fit in the rubber hose pipe.

Figure 50 – Idle air supply pipe (red) – no longer used

While this solution did resolve the problem of the original hose fouling the PCV oil separator, it came with the disadvantage that the amount of air entering the idle circuit was proportionally reduced due to the smaller diameter of the copper pipe. Testing revealed a low idle speed – typically 200RPM lower than expected by the 14CUX, and so the ECU routinely reported fault code 17.

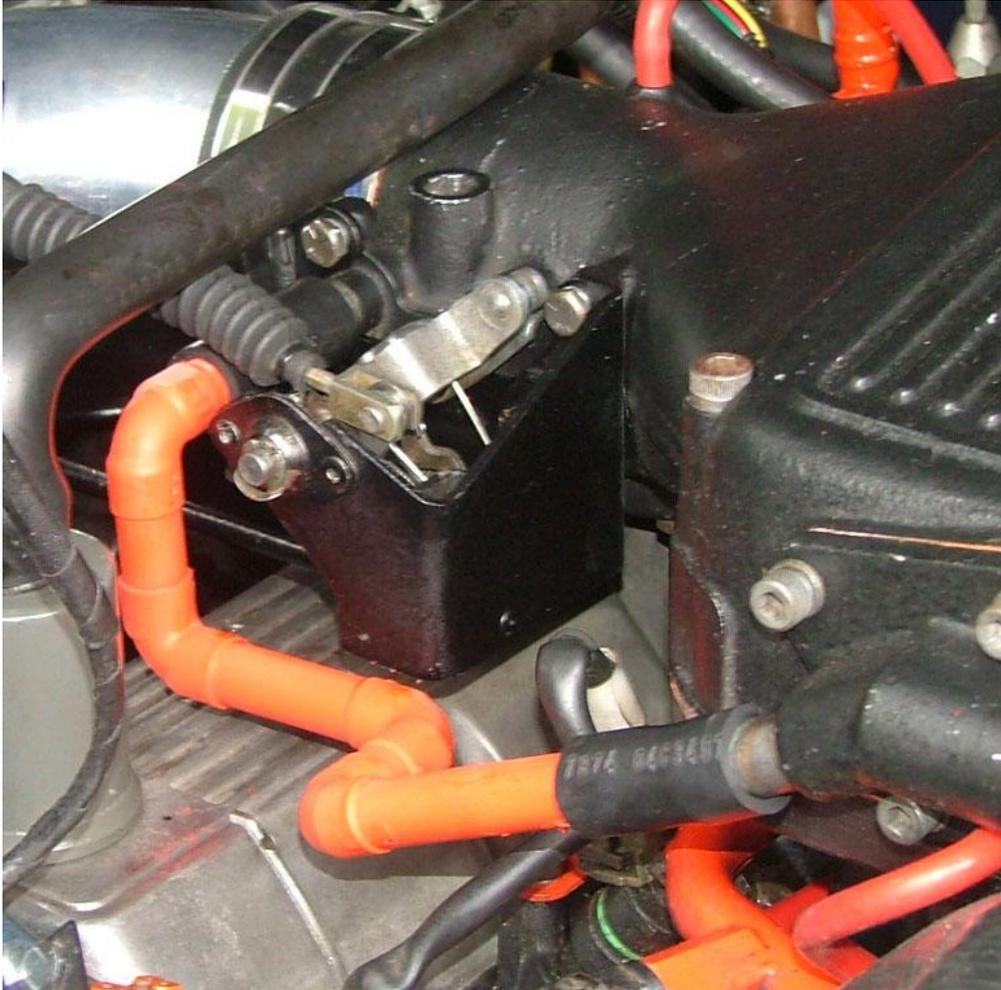
The idle air flow pipe was therefore reconstructed using half inch copper painted red (but with no restrictions) as shown below. The rubber hose ends coupling to the plenum and the idle air valve body were, again, ends cut from the standard hose.

Figure 51 – Idle air supply pipe (red) – finalised

The figure above shows the two rubber joining hoses coupling a red 15mm copper pipe formed to avoid fouling the PCV separator.
