# **Land Rover Series III Engine Coolant Tank Redesign**

**26<sup>th</sup> Feb to 12<sup>th</sup> Mar 2013**

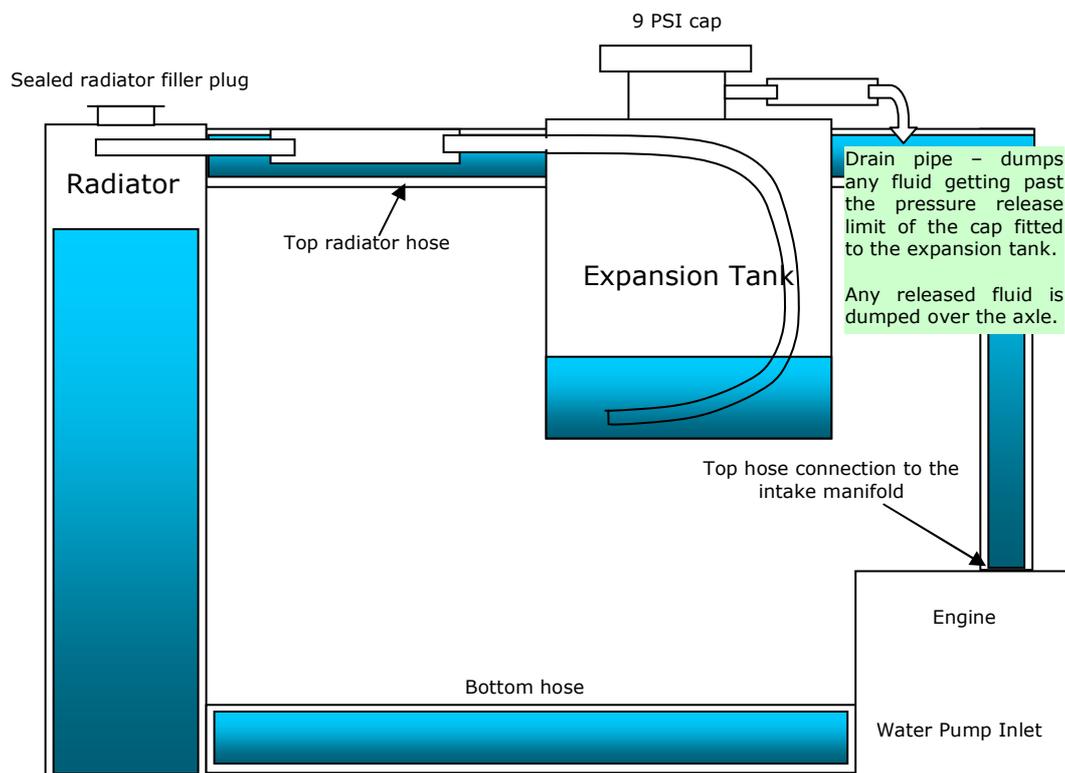
Figure 1 – Existing expansion tank design

In this vehicle the radiator is sealed (i.e. it has no pressure release cap) and has a small diameter free flowing pipe at its highest point, connected via a short horizontal hose to the expansion tank at more or less the same level as shown above and on the same horizontal plane. Inside the expansion tank, the receiving pipe spirals round and down to the floor of the tank and is consequently submerged in coolant fluid. The tank is fitted with a traditional pressure release cap rated at 9PSI. When filling the system – the radiator is slowly filled to capacity and sealed. The expansion tank is then partially filled to a marker level about mid way up and sealed. Sufficient time is allowed during this process so that air in the engine and intake manifold bleeds out.

When the engine heats to normal temperature any coolant expansion in the radiator will first expand to fill whatever space may exist at the top and then go on to pass fluid through the short hose pipe into the expansion tank.

When the engine cools and the coolant contracts, that process generates a partial vacuum in the radiator compared to pressure in the expansion tank, sufficient to cause coolant to flow back from the expansion tank into the radiator so concluding the cycle.

If the expansion tank were to fill beyond capacity then the pressure release cap would open once the internal pressure reached the release point. Fluid would then be expelled via the drain pipe and dumped onto the ground – but this condition should only occur if (a) the entire system is over filled with fluid, and/or (b) the system is over pressurised beyond the limit set by the pressure release cap.

There are however a number of disadvantages with this design. The first is that the operator cannot fill the cooling system via the expansion tank alone. The radiator or some other filling point has to be used instead. The second is the systems dependency on pressure differentials being accurately maintained in order for the transfer of the right amounts of fluid. If that doesn't work for any reason, or is inaccurate over time, then the operation of the system will be compromised. The third is that the movement of fluid is relatively sluggish – given it operates over the time required to either fully heat the fluid from cold, or fully cool the fluid from hot. The last (in this particular case) is that the coolant level cannot be seen because the expansion tank is opaque.

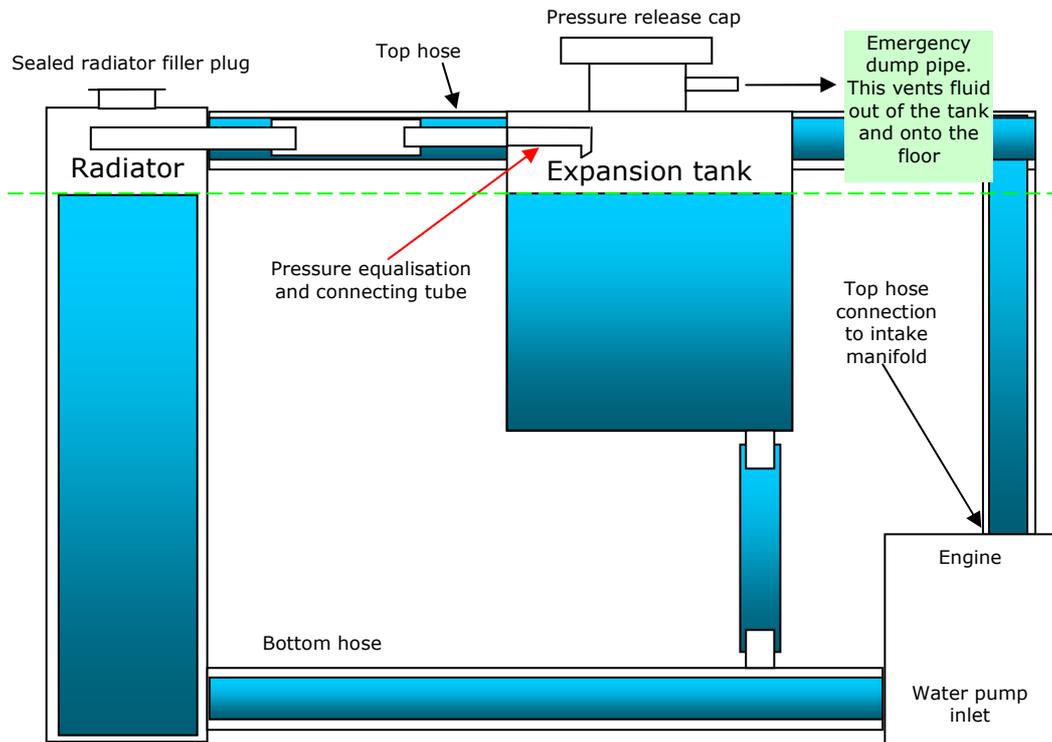
Figure 2 – Expansion system refinement

In this variant the expansion tank now has two connections. The top connection is similar to that used before but this time remains above the fluid level inside the expansion tank and is used to equalise pressure in the two vessels. A second relatively large connection links the expansion tank to the lowest point in the cooling system (usually to the lower radiator hose via a T connection).

1. Both vessels are connected below the level of the fluid
2. The rise in level is not restricted in either vessel.
3. There are no leaks
4. The relative pressure above the fluid, in both vessels, is the same.

The job of the pressure equalisation hose is to ensure that point 4 above is true at all times – in which case, and in this example, point 2 will also be true. If either of these assumptions is false then the system can and will airlock under filling conditions.

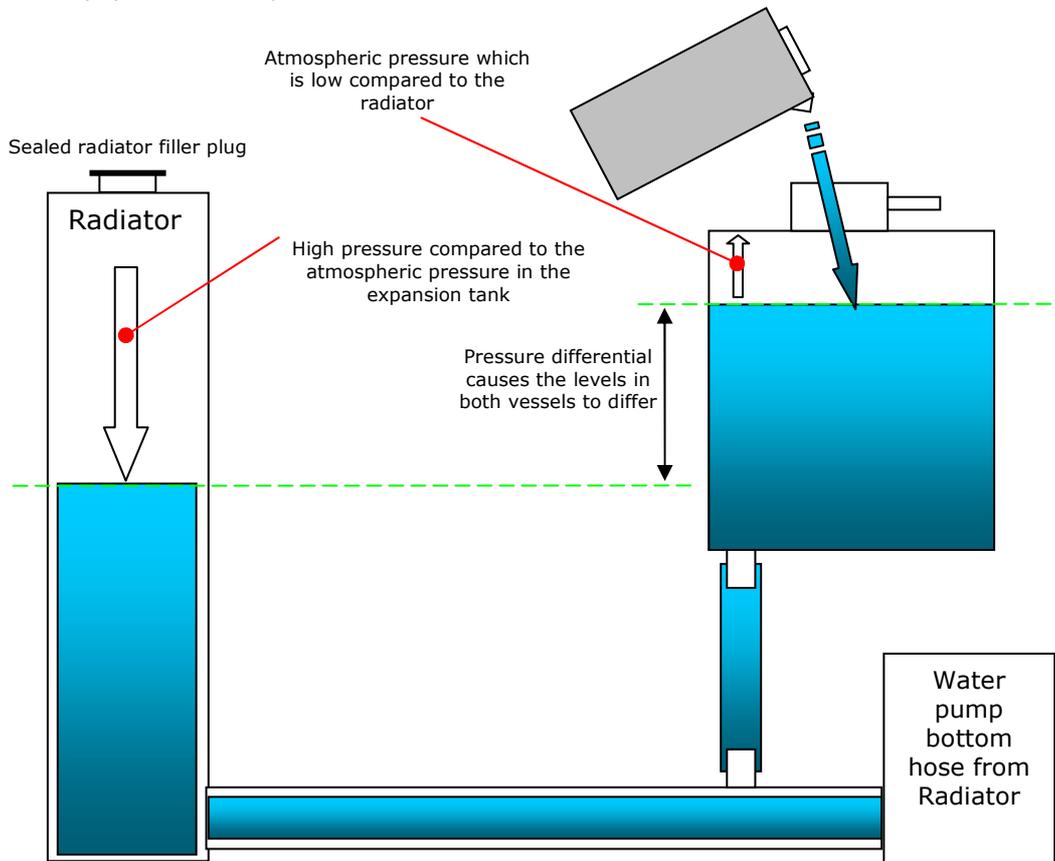
Figure 3 – Expansion tank without any equalisation

As the fluid slowly fills the system it will cause the level in the radiator to raise and in doing so will compress the air volume above the fluid, due to the increase in fluid and the fact that the air volume above cannot escape. At some point the pressure will elevate sufficiently in the radiator so that fluid will simply stop rising and will only rise in the expansion tank. The system now has an airlock.

*Under these circumstances it would be reasonable to conclude that the system is filled based on the level in the expansion tank, not realising that the radiator was in fact only partially filled.*

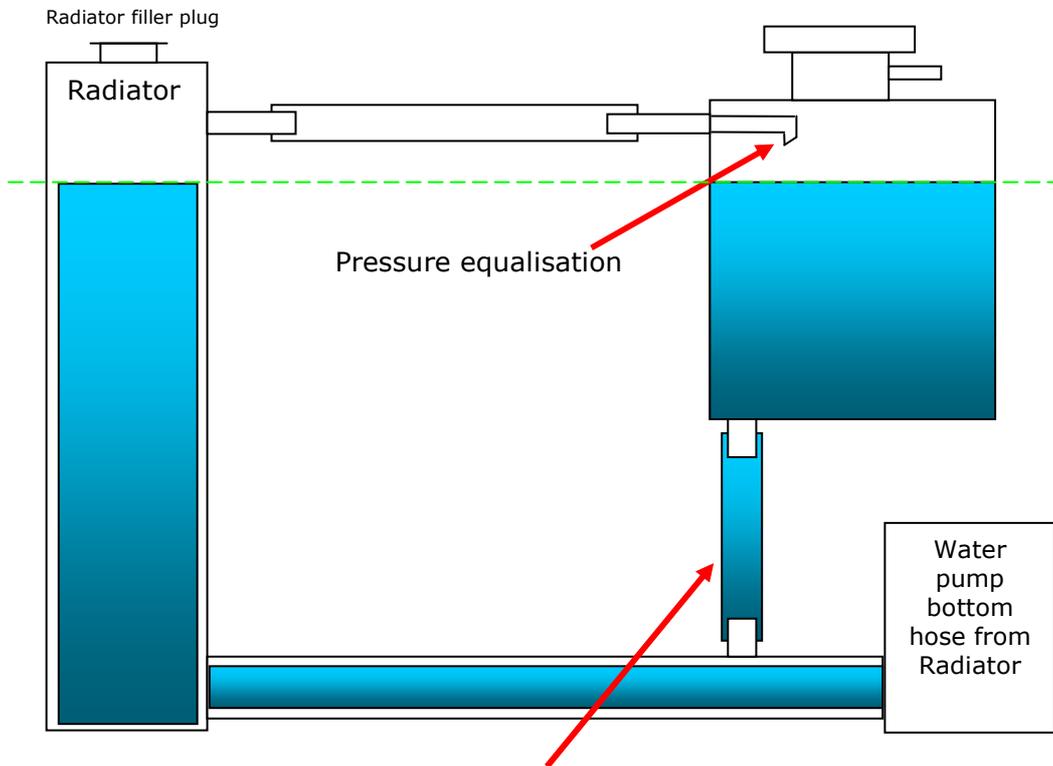
Again – ignoring the top hose, and turning our attention to the second expansion tank hose pipe – this is typically a 16 to 20mm hose coupling the base of the expansion tank to the lower radiator hose via a T connection.

Assume for a moment that fluid in both vessels has been set at some notional “Normal” level slightly below the top of the radiator and the system is filled. Due to the equalisation pipe, the pressure in both vessels will be the same, and so the fluid level of the coolant in the radiator and expansion tank (and via the top hose the engine and intake manifold) will be the same.

If the engine is now run, the coolant will slowly expand as the engine heats and the increase in fluid volume will equally fill the free space at the top of the radiator<sup>1</sup> and by the same amount the free space in the expansion tank – levels will remain equal. Eventually the coolant will reach the top of the radiator when no more expansion is possible at which point the level will start to rise higher in the expansion tank. As the engine cools the fluid will contract and the decrease in volume will immediately cause the level in both vessels to reduce to their original “Normal” levels. All the time the pressure is equalised continuously throughout the heating and cooling cycles in both vessels.

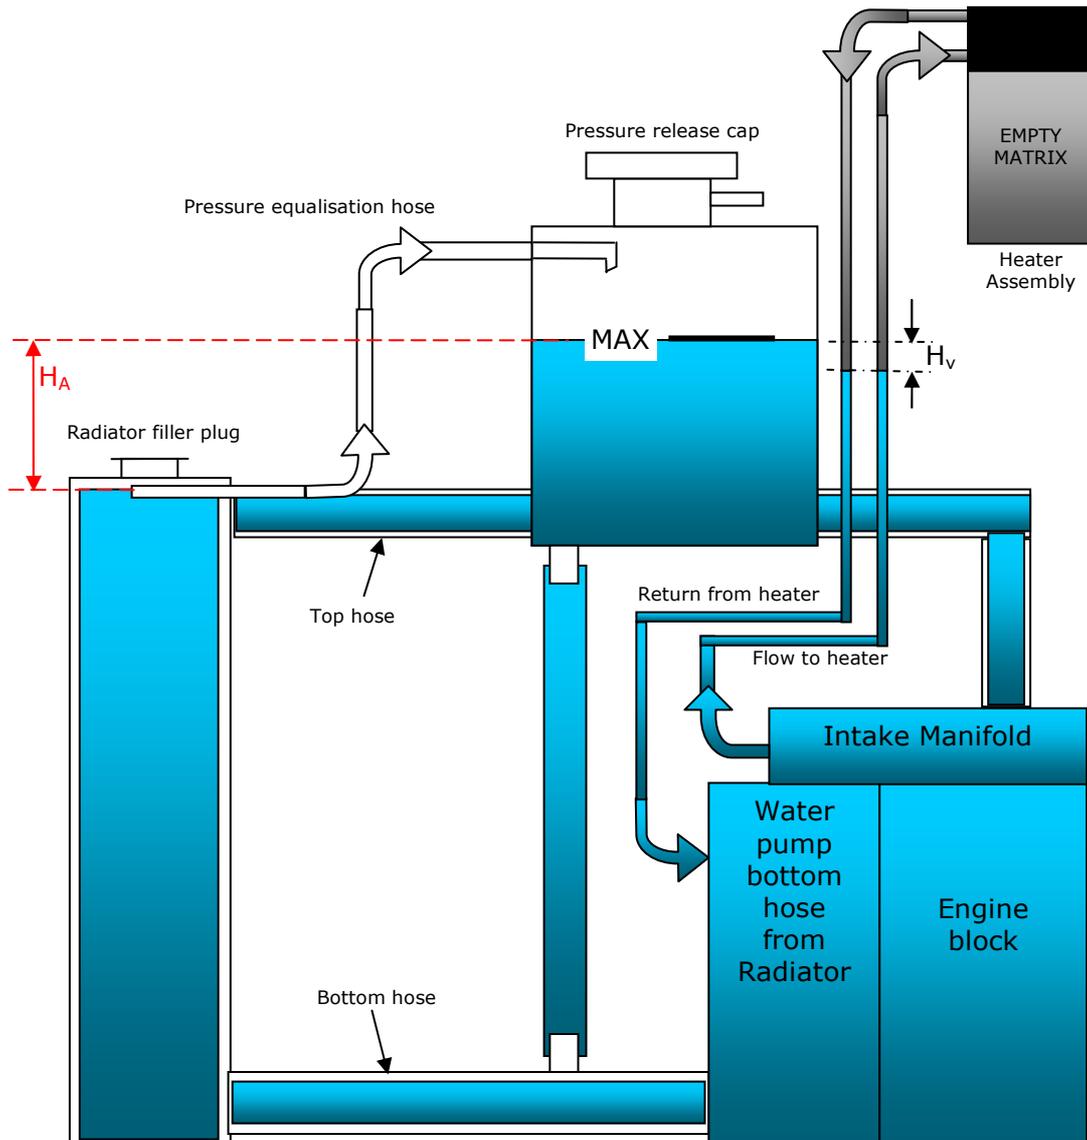
Figure 4 – Partially filled cooling system in the Land Rover

A more realistic coolant system schematic for this vehicle showing the expansion tank, complete with modification could be illustrated as follows. Assume that our starting point is an entirely empty cooling system (including the heater matrix) and that the operator has now slowly filled the system to the MAX line of the expansion tank but has not yet run the engine. In this case we would have the situation shown below.

In this scenario as fluid is added to the expansion tank, the radiator will slowly fill to capacity, as will the engine, intake manifold and water pump - given they are pressure equalised via the top hose and the pressure equalisation hose. The heater matrix however will give rise to an airlock as it is a sealed unit mounted high and cannot equalise pressure. Even if the heater matrix was somehow able to equalise pressure (i.e. if it contained some kind of vent), the fluid in the flow and return pipes would still only ever reach the MAX line of the expansion tank anyway but with the additional back pressure created by the air lock in the matrix, the coolant level will reach some level below the MAX line (see H<sub>v</sub> above) and go no further.

The head distance between the MAX level on the expansion tank and the top fluid level in the radiator is shown as  $H_A$  in the above diagram. This size should be positive – in the sense that the MAX level in the expansion tank should be equal to or higher than the highest fluid level in the radiator. The more positive it is the more reserve of coolant fluid will be available.

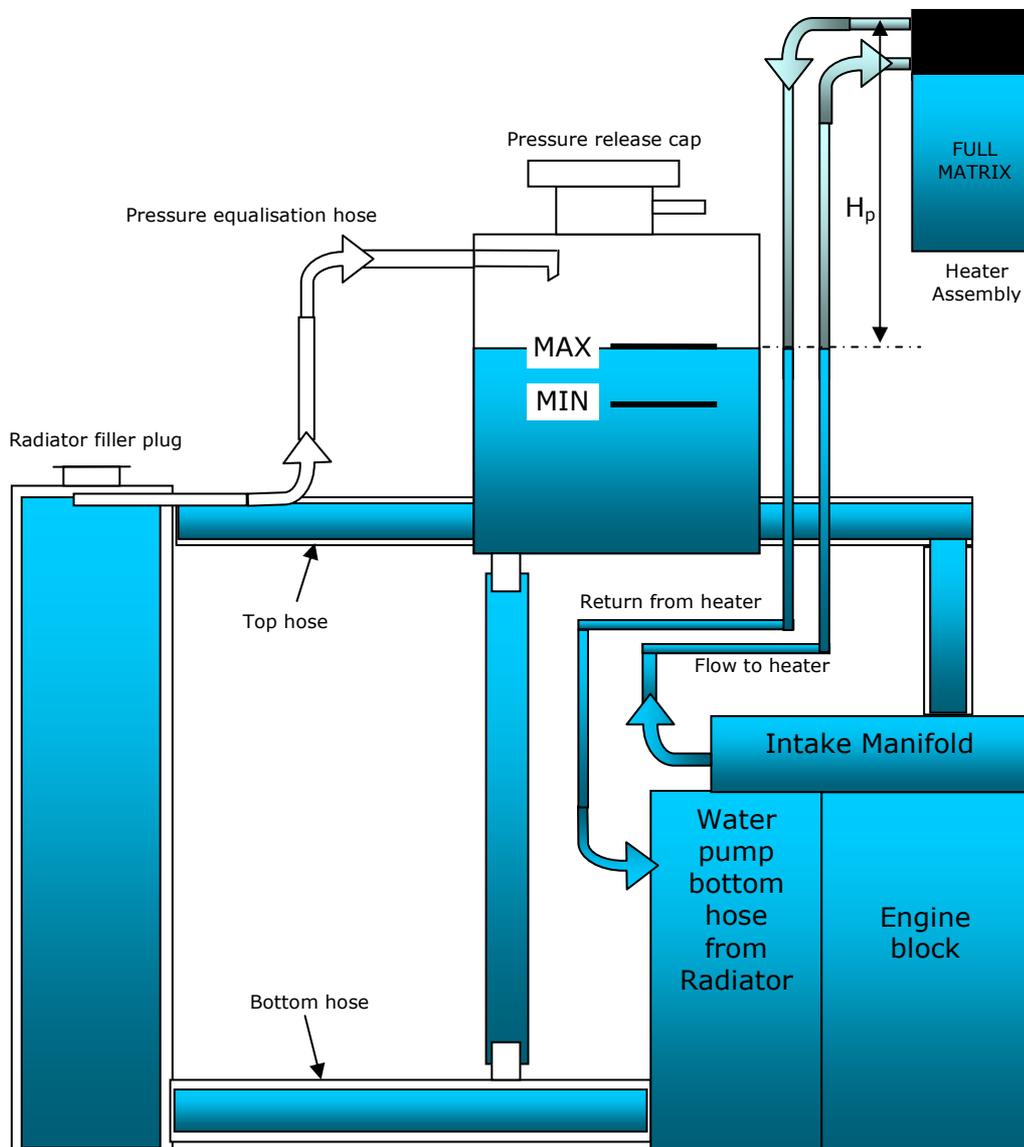
Figure 5 - Completely filled cooling system in the Land Rover

The heater matrix will now be filled to capacity, and due to the fact that the flow and return pipes feeding it are on the top of the heater assembly, will remain filled close to capacity because the coolant fluid is effectively trapped (in fact the level in the matrix will actually reduce very slightly due to thermal contraction once the fluid cools). The area above the MAX line of the expansion tank, and the top of the matrix (see line  $H_p$  above) only involve short runs of two 16mm pipes, and in fact these will actually air lock and form a low pressure area of fluid as the coolant contracts because they have no way of drawing air into the system (shown as a slightly different colour in the diagram).

As soon as the engine starts again – the pump will fill this relatively small low pressure area ( $H_p$ ) instantly and so a system in this state and with no other leaks will remain stable.

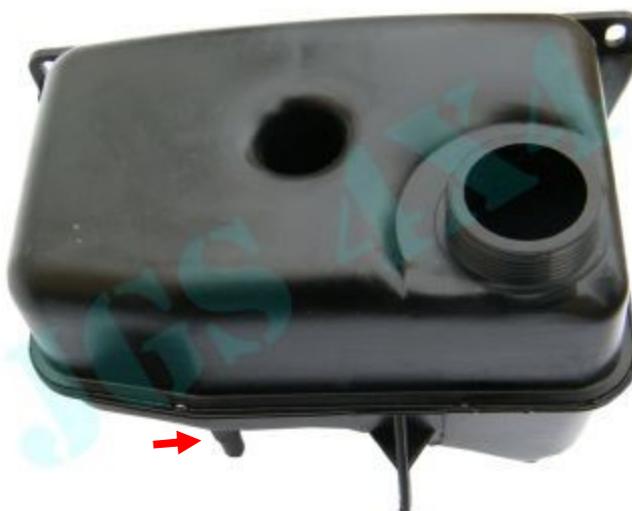
*Figure 6 – Standard (old style) defender expansion tank*

The first is the physical size. Given the amount of room available, it would be extremely difficult to squeeze this into the engine bay. The second is the pressure equalisation pipe is not above the fluid. It is underneath the unit (see red arrow). This means that the pressure equalisation link between the radiator and the expansion tank will be at different heights with one above and one below the fluid level. Being completely honest, I'm not 100% sure if that's a problem or not, but it feels like it might be. The third problem is that you can't see the liquid level inside. While that feature isn't exactly essential, it is a very *desirable* quality of any modified system we may make. The fourth and last problem is two fold: First the cap on these expansion tanks is rated at 15 PSI, rather than the 9 PSI I am currently using. Second because it's a screw in cap, I can't just fit another – and as far as I can see there is no alternate supplier of a lower pressure cap.

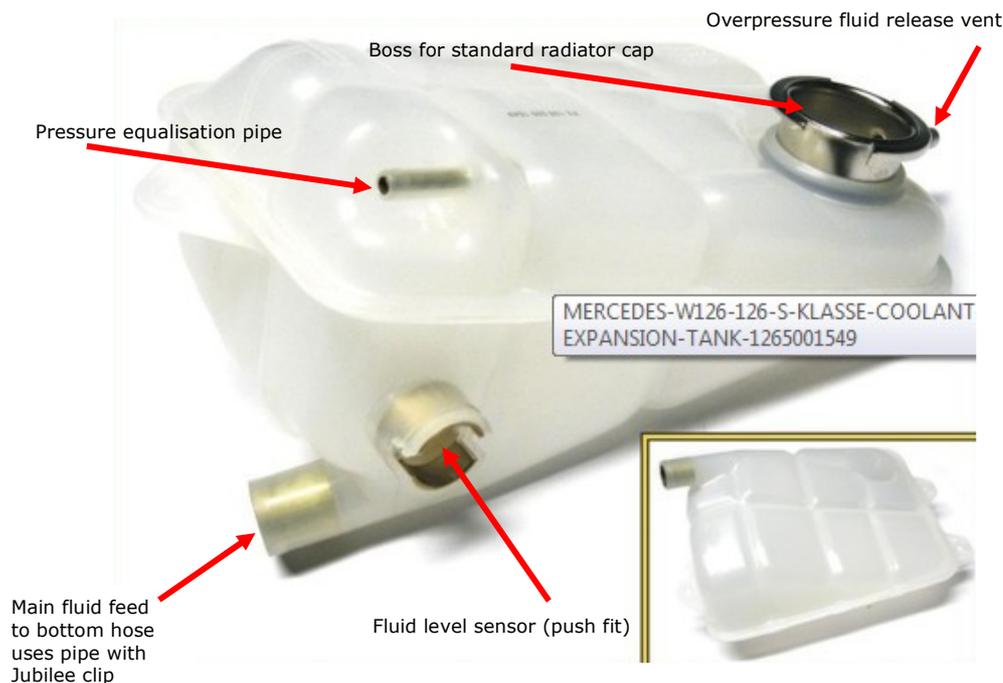
Figure 8 – Mercedes 500 SEL expansion tank

I trawled a well known auction site for alloy and plastic coolant tanks – and basically nothing looked right – until I spotted these Mercedes parts. 500 SEL's use them and so unsurprisingly the volumetric capacity looks about right for a small block. Estimating the outer dimensions also confirm that the tank will snugly fit into the space where the existing tank resides. The best fit has the cap nearest to the wing – but either orientation looks feasible. The tank has a built in switch for level monitoring – which unfortunately we are obliged to fit (to fill the hole) so we could optionally use that sensor if we fancy it.

This tank has a number of desirable qualities. All the pipes on this tank couple via jubilee clips and the tank also uses the boss for a standard radiator cap. It has three very simple but strong looking mounting points (two on the end with the cap, and one on the other end) and both the pressure equalisation and main feeds exit on one side. Additional pictures of cheaper second hand, but rather rough looking items, offer useful viewpoints as follows:-

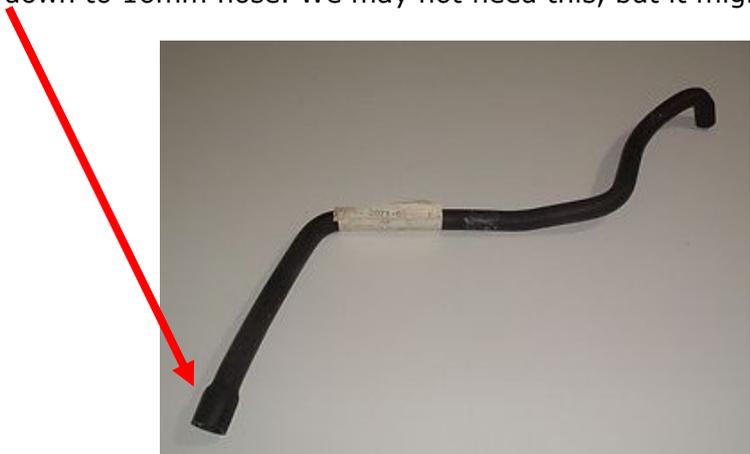
Figure 9 – Mercedes expansion tank connection hose

I separately purchased the connection hose for the main feed (this will connect to the T in the bottom radiator hose). It has a specially expanded end but then shrinks down to 16mm hose. We may not need this, but it might also be handy.

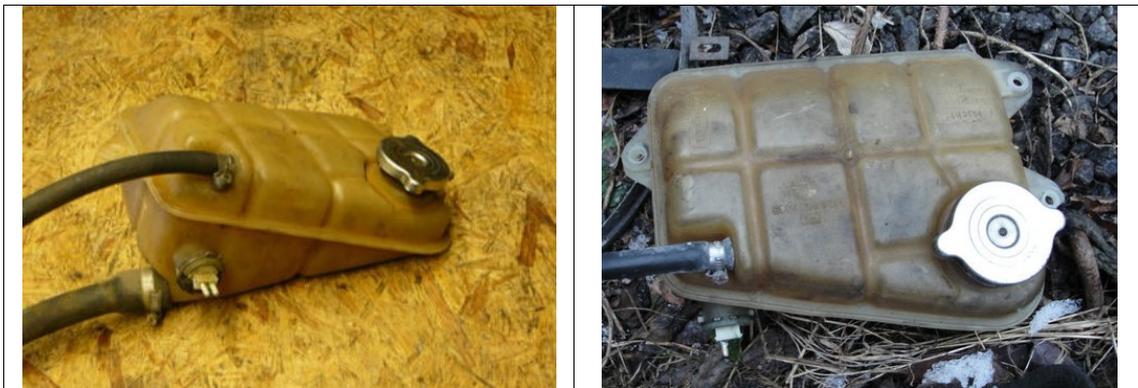
Figure 10 – Second hand Mercedes Expansion tank examples

Both images are interesting – and the 2<sup>nd</sup> of the two is helpful given we can predict the scale of the overall size, simply by reference to a radiator cap. The diameter of a radiator cap is:-

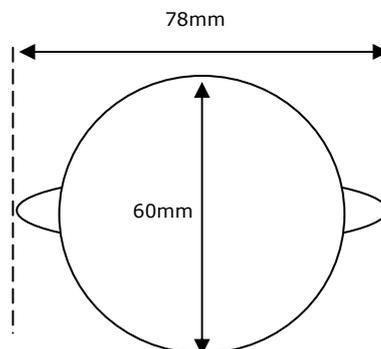
Figure 11 – Typical radiator cap dimensions

In the picture the radiator 60mm diameter is 90 pixels and the 78mm dimension is 126 pixels. That means that very roughly any pixel dimension can be divided by 1.5 to get the size in mm. In which case we get the following rough estimates

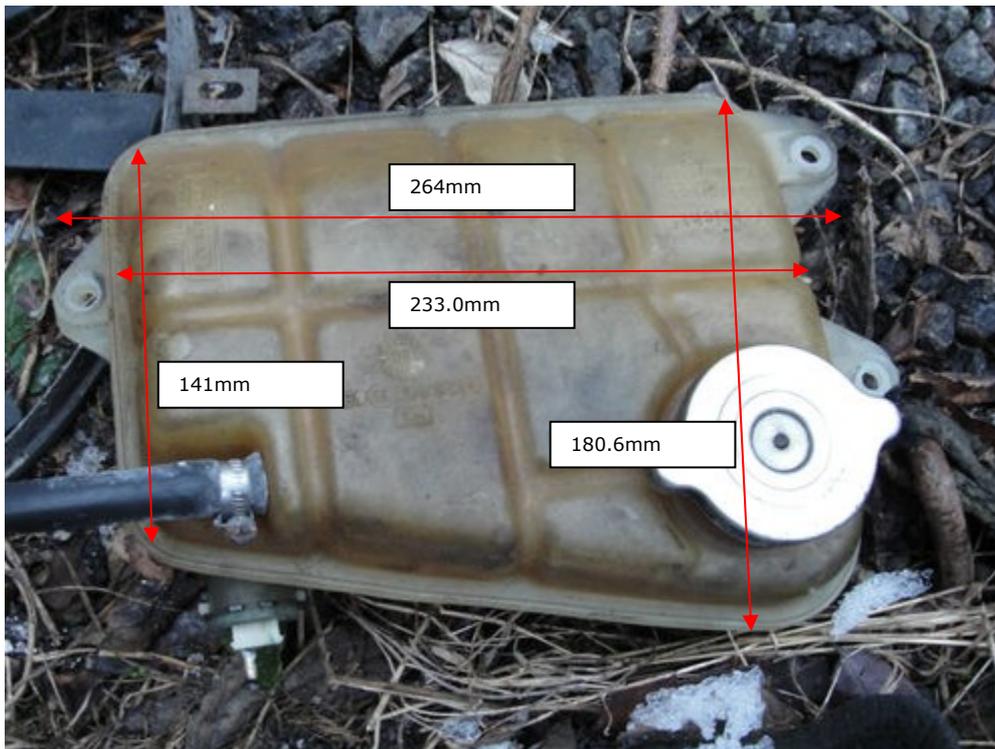
*Figure 12 – Estimates of sizes for Mercedes Expansion tank*

Subjectively it's a big tank but if these dimensions are used to cut a cardboard template, it is clear that we should be able to fit it somewhere under the hood. Key advantages of this tank are:-

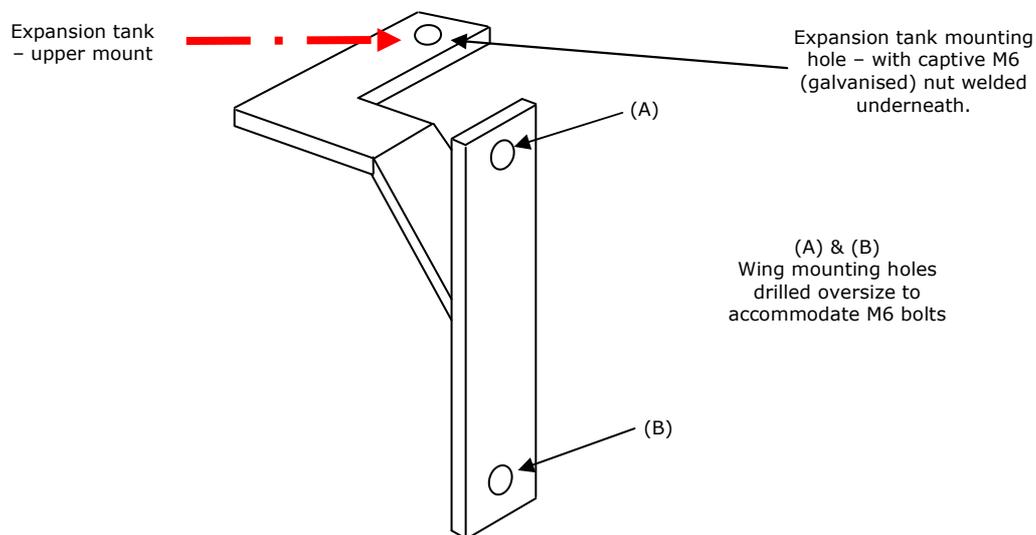
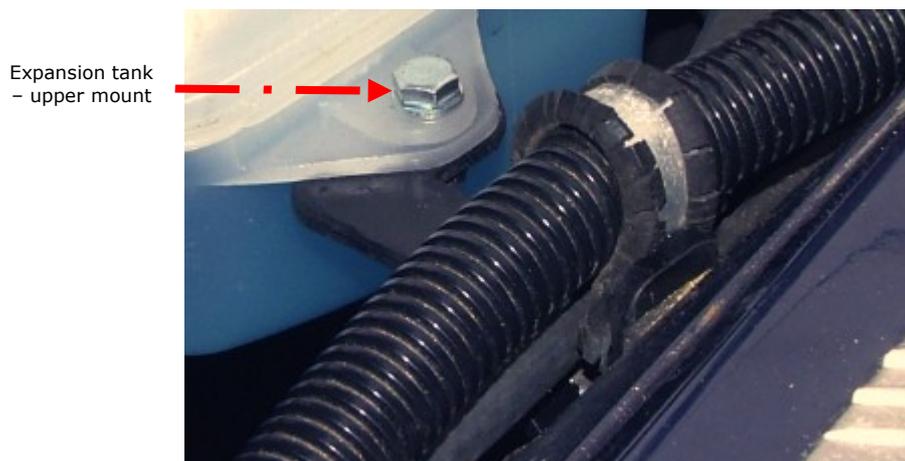
Figure 14 – Wing side expansion tank mount

The photo below shows the expansion tank mount on the driver side wing. The top hole is used to mount the tank and has a captive M6 nut welded underneath, while the two other holes are drilled oversized to accommodate M6 bolts (7.5mm). Out of those two, the bolt passing through (A) also holds one of the P clips securing the loom. The steel used in the bracket is heavy gauge (roughly 4mm). A schematic and photo of the area are shown below.

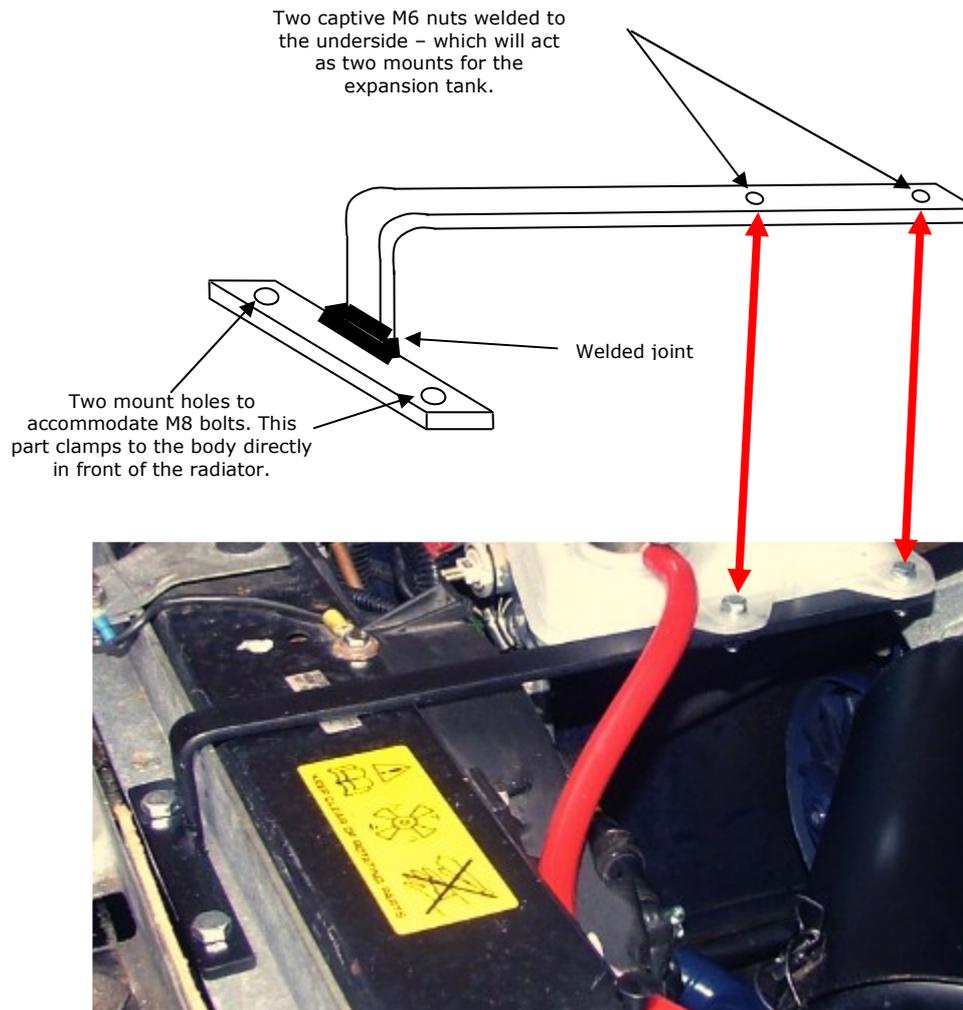
Figure 15 – Second long expansion tank mount (using two captive nuts)

The second mount is quite different from the first. Shaped a little like an L – it fixes to the galvanised structure at the front of the vehicle via two M8 bolts and uses two captive M6 nuts welded onto its reverse side to secure the expansion tank. Again it is constructed out of heavy gauge steel (roughly 4mm) – but with just enough flexibility (spring) to allow for a degree of flexing at its far end. The

weld between the base plate and the L bracket is not a butt weld. Instead the L bracket is cut into a recess in the base bracket so that it is completely pinned – and then welded on the back, bottom and front. A schematic and photo of the mount are shown below

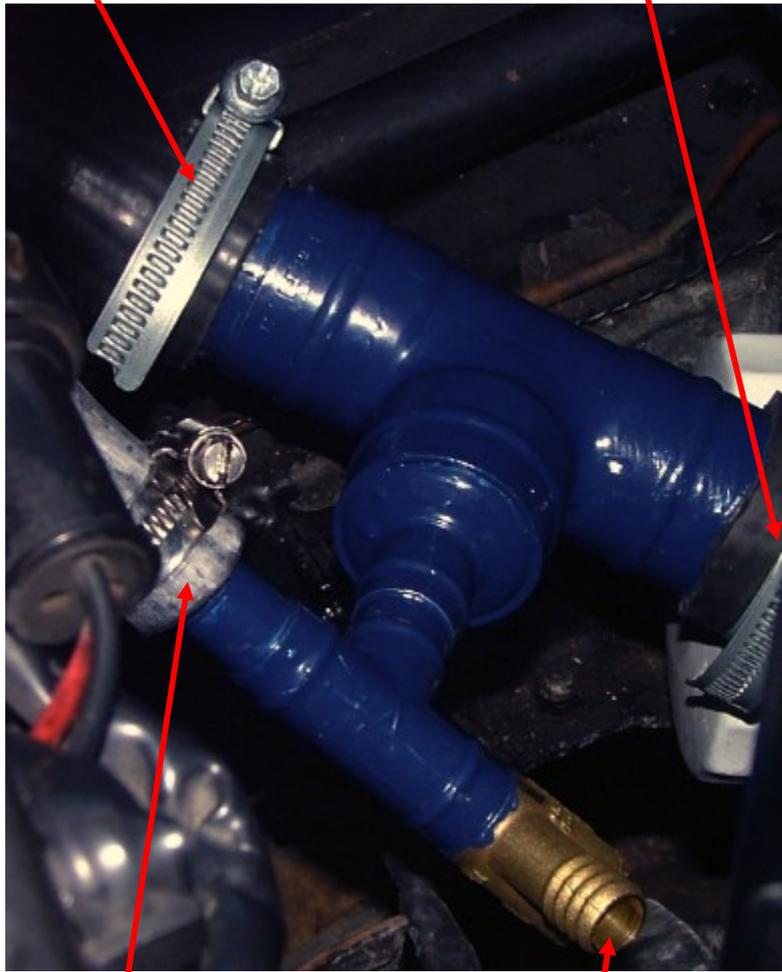
The fit of the bottom hose copper T piece came next. This had a number of objectives. It first needed to couple the two halves of the custom lower radiator hose – something that required the hose to be shortened by about 3 inches. Second it needed to clear the steering system and the oil filter while at the same time presenting a good line for the connection to the expansion tank main feed. Third it needed some way to easily drain the cooling system down using a domestic drain valve.

Clamp on bottom hose (end going towards the radiator)

Clamp on bottom hose (end going towards the water pump)

Clamp on 16mm ID hose connecting to expansion tank main feed

Drain cock valve used to partially drain the cooling system.

With this new arrangement it is easy to drain a full 5 litres of fluid from the system.

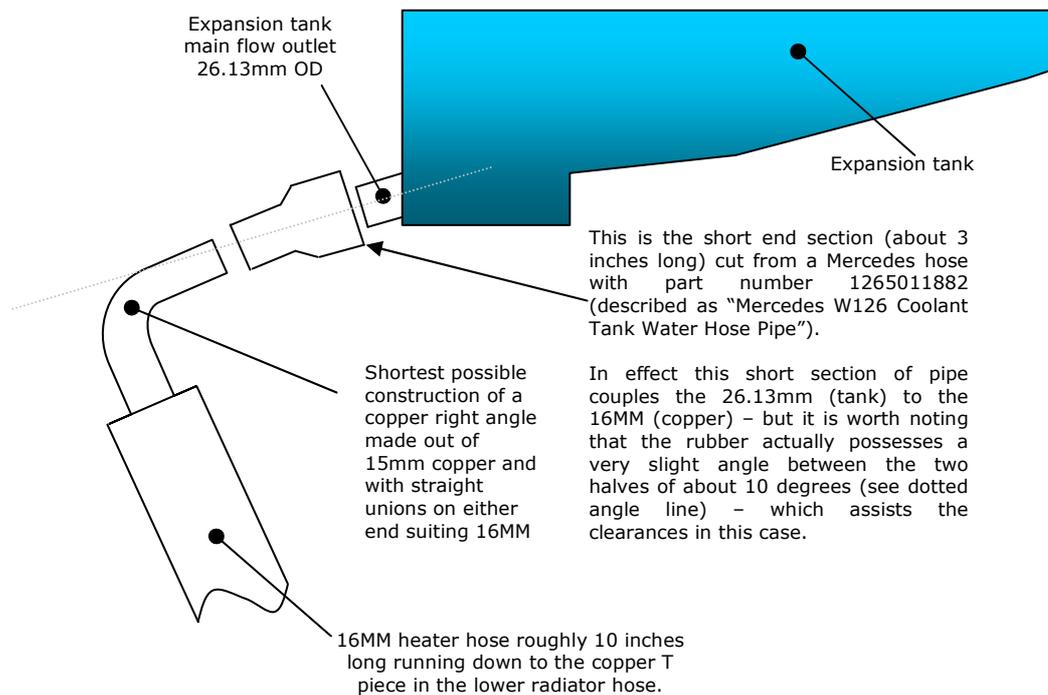
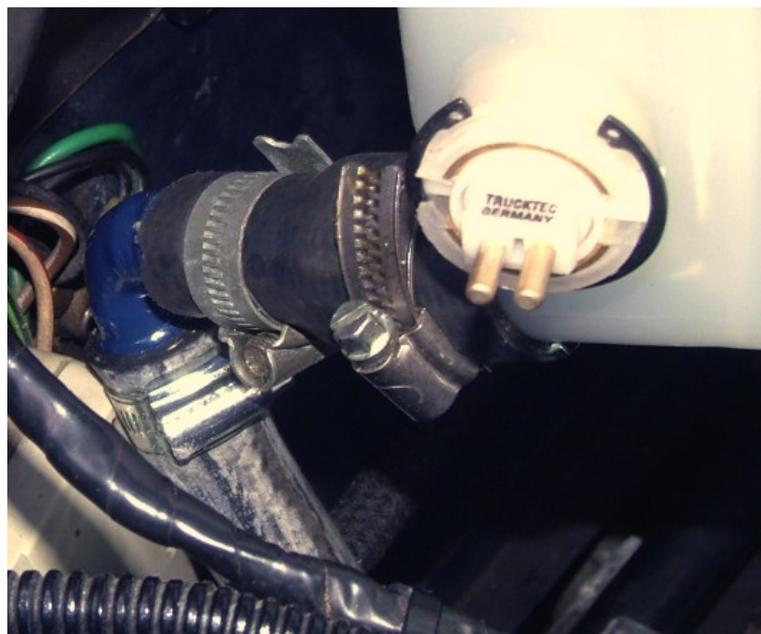
Figure 17 – Expansion tank main feed and copper union

The photo below shows the main outflow feed from the expansion tank – which itself connects to the lower radiator hose T piece shown above. This connection is built as follows:-

A straight length of 16mm ID hose connects the copper right angle under the expansion tank to the lower radiator hose T coupling. The end result is a good solid connection with no hose stressed. The top view is shown below with the level sensor in the fore view.

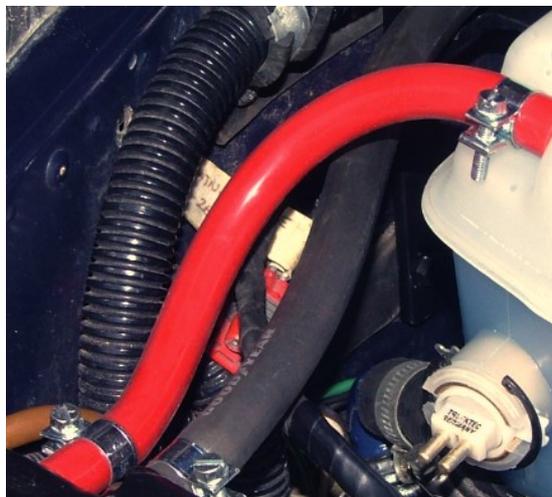
*Figure 18 – Radiator pressure equalisation hose (red) and Plenum return hose*

The 6.3mm pipe, by contrast, is a threaded adapter screwed into the body of the header tank and is simply an exposed pipe inside the radiator fitted roughly 1cm down from the top.

The 6.3mm threaded outlet was therefore unscrewed and its flared pipe flange removed. A piece of copper pipe with OD 8mm was then soldered onto the original 6.3mm pipe in order to provide the required diameter. A flared end was then added by soldering & smoothing a solder lip. The adapter was then threaded back into the radiator with a new copper washer, and Hylomar blue sealant. The hoses were then connected – red silicon as the pressure equalisation hose, and the existing (black) plenum return hose.

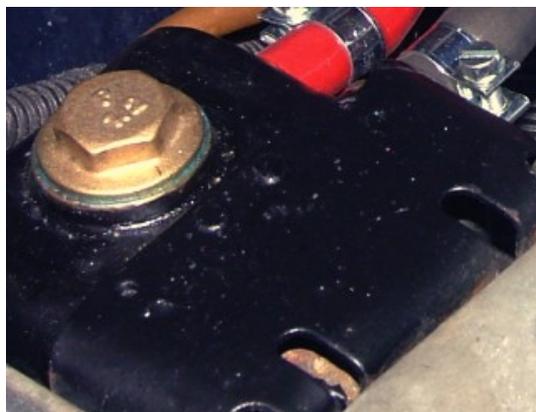
*Figure 19 – ½" BSP plug bolt on radiator*

At the same time a new ½" BSP brass plug was threaded into the now repaired radiator flange, and sealed with Hylomar blue. It was tightened using an 18mm socket (but not using an impact gun) as shown below.

Today I wanted to look at the damaged flange on the radiator. This is the sealing flange of a filling hole on the top of the side mounted header tank (on the driver side). This area is all made of brass and the hole itself is threaded 1/2" BSP – with the sealing flange raised about 4mm above the brass skin of the header. It is roughly 25mm in diameter with a 4mm sealing face and is threaded for a 1/2" BSP brass plug bolt.

Looking at the scoring after cleaning the area, one score in particular would have required the entire flange to be ground down by maybe 1/2 to 3/4mm in order to flatten it - which would have taken the flange uncomfortably close to the top of the plug thread. An alternate method of repair would involve blocking the threaded centre of the hole with some kind of metal pipe which couldn't be soldered, and likewise fitting a containment ring round the outside of the flange

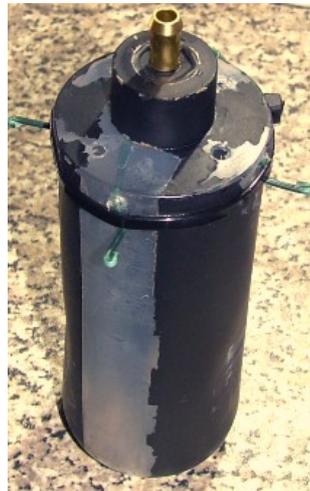
*Figure 20 – Modified pressure release catch-canister*

The final task was to extend the pressure release vent outlet (immediately above the pressure release cap) via a silicon hose, and down initially to the floor (via the cross member). In order to tidy this, the hose was P clipped to the radiator mounting bracket and a previously created (and rather crude) plastic catch-canister with an 8mm brass connection was further modified so that it could be dropped into the large fixed hole in the chassis and self lock into position.

The canister is shown below with an 8mm flared connection at the top, a number of vent holes for pressure equalisation and two galvanised wires about 3 inches long passing straight through and which are folded down (to lock) and then secured with a cable tie. While really quite crude the catch-can should never be required, and so is purely a fall back to prevent fluid loss occurring in unusual circumstances.

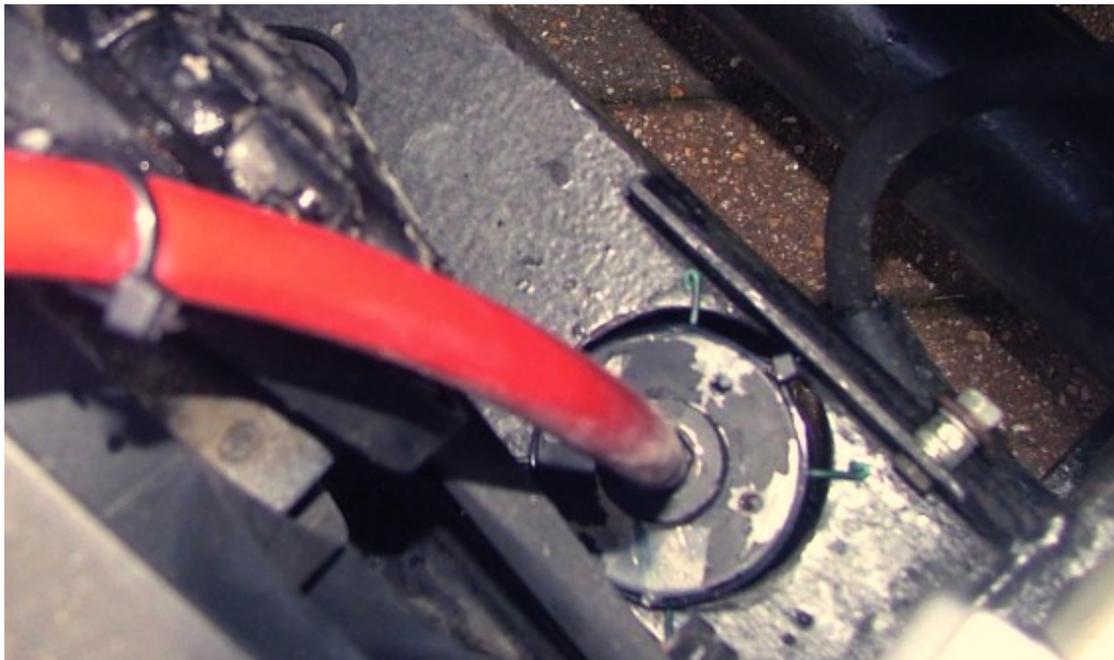
*Figure 21 – Catch-canister fitted into chassis*

When fitted to the chassis, the catch-can looks as follows. It is very easy to remove and empty if need be.

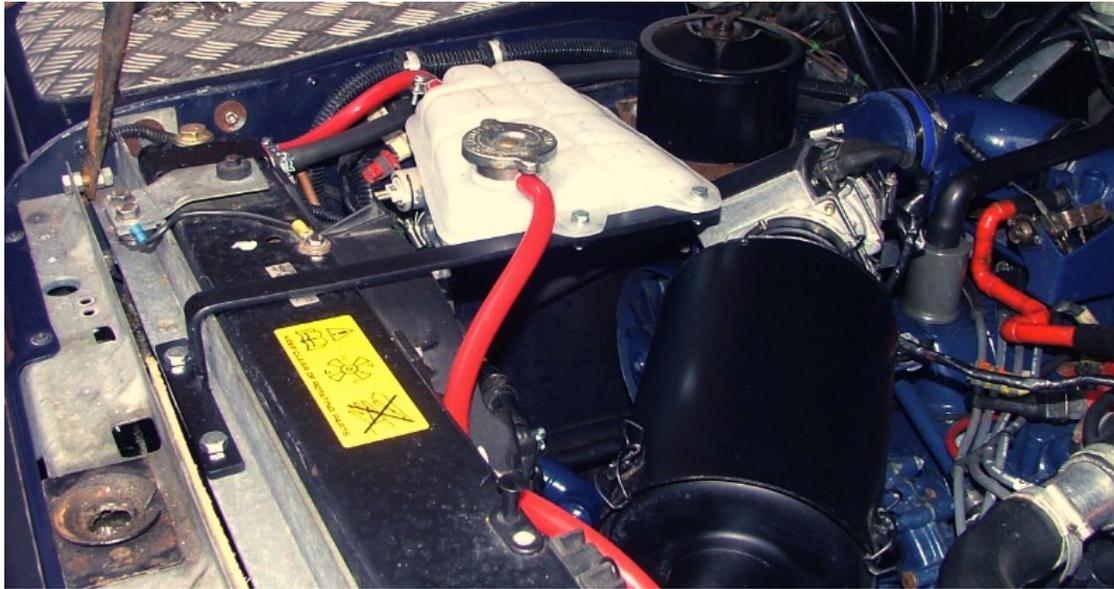
*Figure 22 – Final fixing viewed from passenger side front*

The end result of the expansion tank is shown below, using two different viewpoints.

With this expansion tank fitted – we know precisely what it does, and we know it will work. We can also view coolant fluid levels and can drain twice the amount of coolant fluid with far less mess. We also don't need to disturb the plug bolt on the radiator.
